The Rail Safety
Inspection Office

NIB ANNUAL REPORT 2018

according to Article 23(3) of Directive 2004/49/EC

September 2019

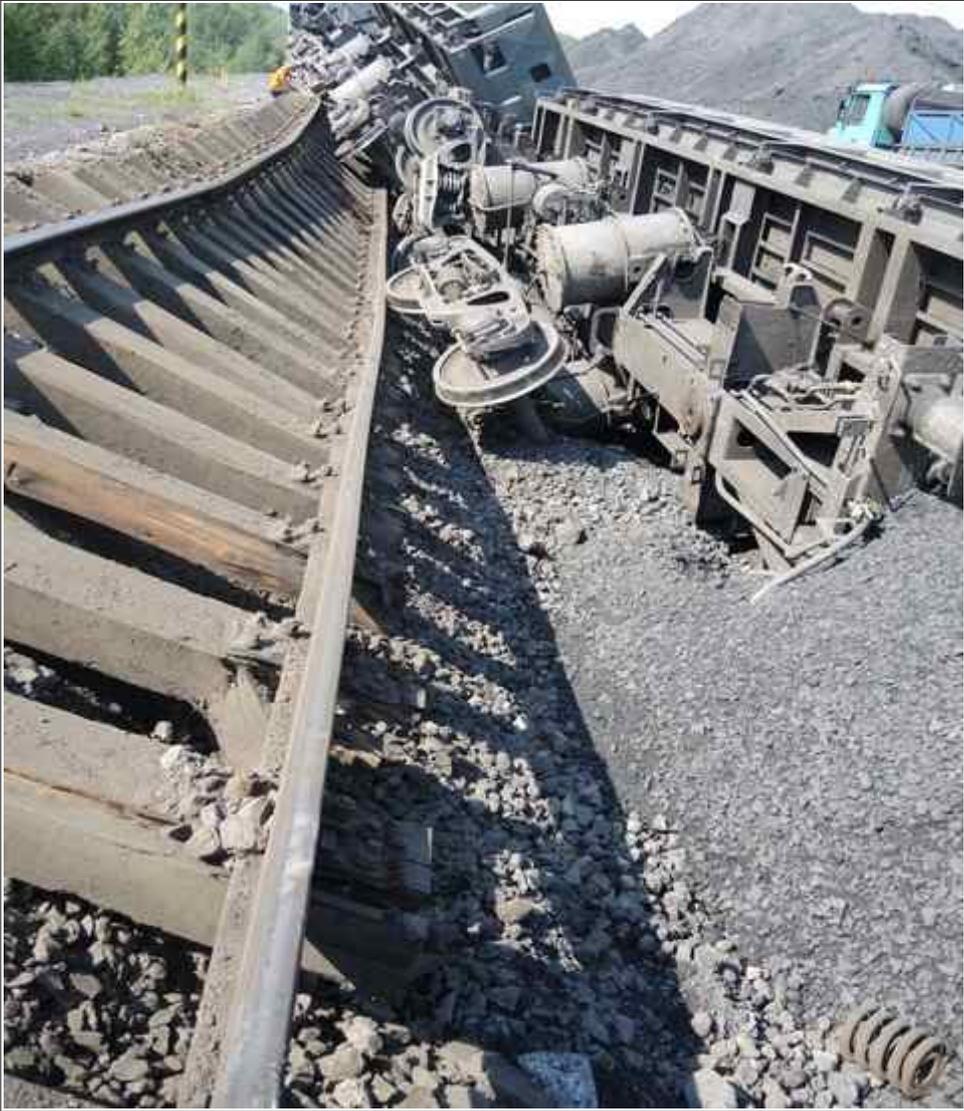
- Grade: a serious accident.
- Date and time: 5th June 2017, 5:53 (3:53 GMT).
- Occurrence type: an unauthorized movement.
- Description: the unauthorized movement of the long distance passenger train No. 1342 behind the main route signal device Sc5 with the consequent collision with the concrete buffer stop at the end of the station track No. 5.

- it is recommended to adopt own measure forcing installation of the technical device for emergency stop of the trains, which will be automatically activated when the rolling stock unauthorizably moves behind the main signal device on railways where installation of the system ERTMS (European Rail Traffic Management System) is not planned.

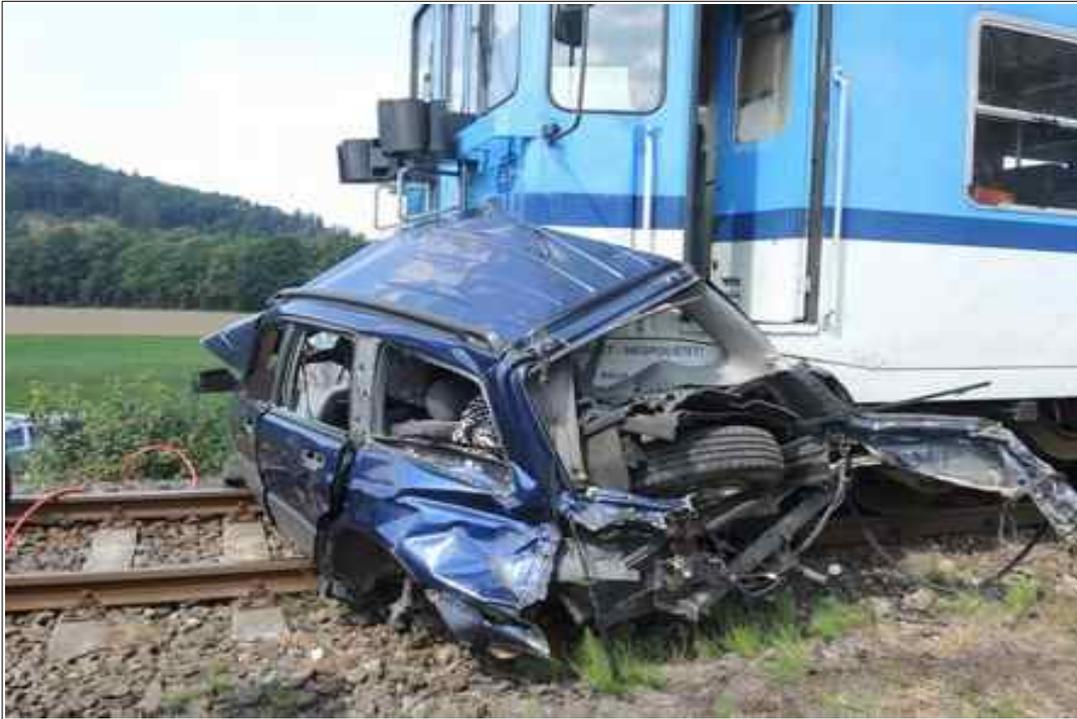
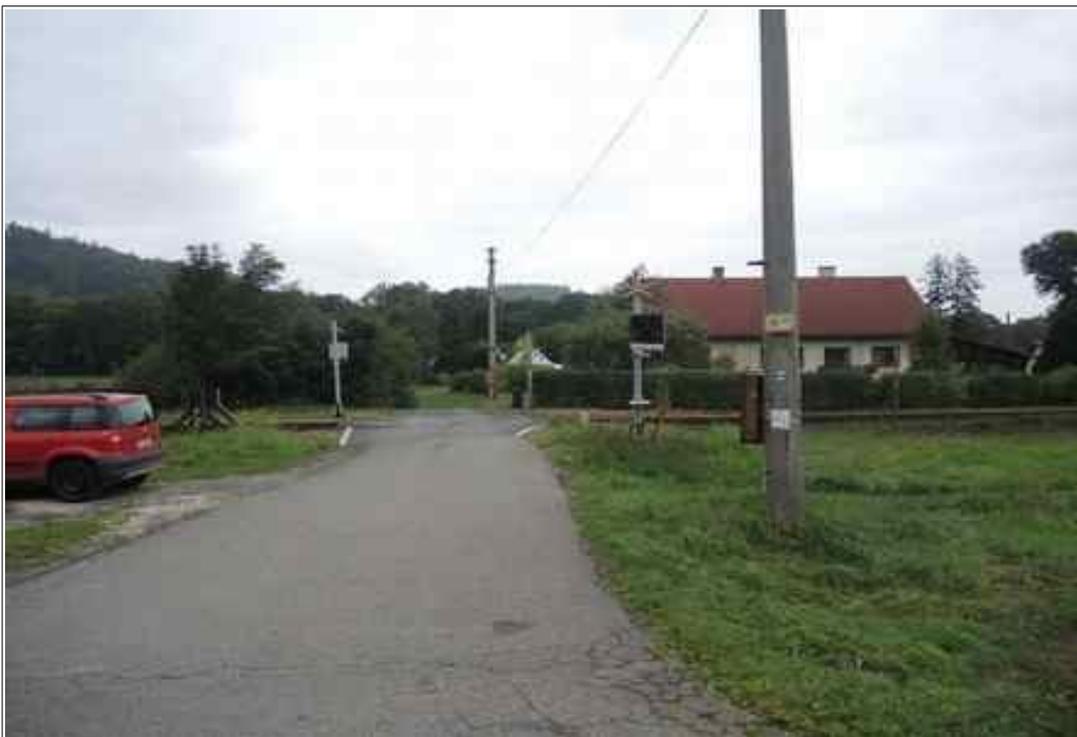
- Grade: an accident.
- Date and time: 18th August 2017, 14:33 (12:33 GMT).
- Occurrence type: a level crossing accident.
- Description: the collision of the passenger train No. 24811 with the car at the level crossing.

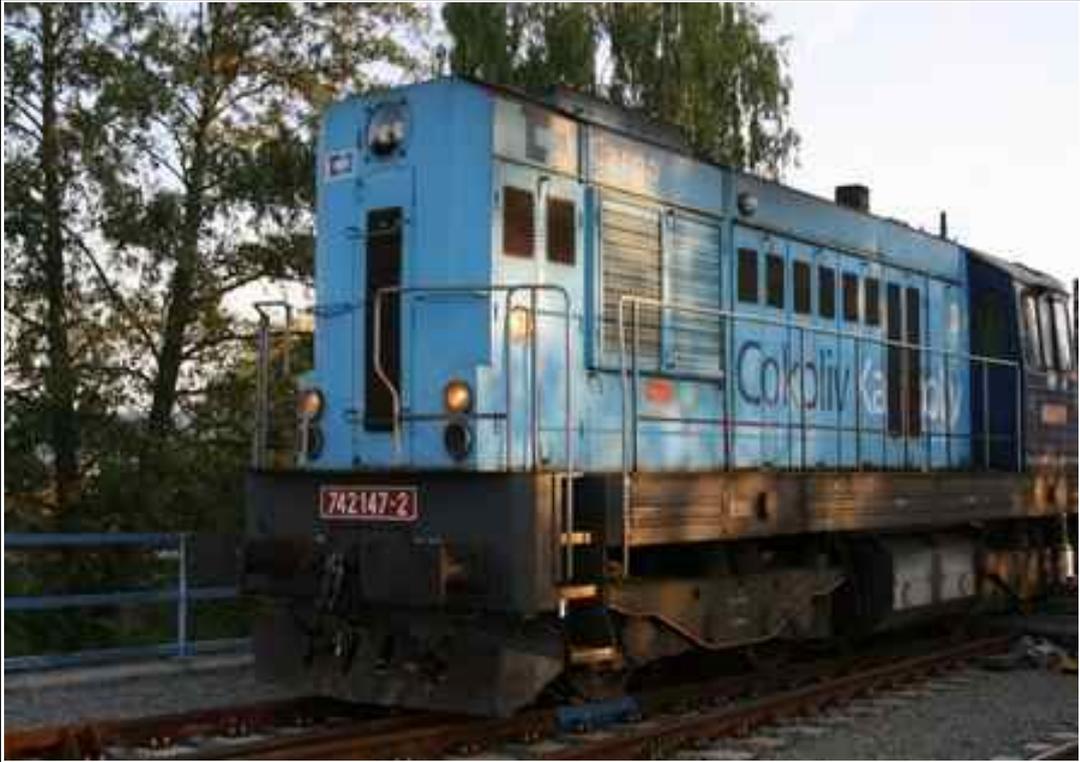
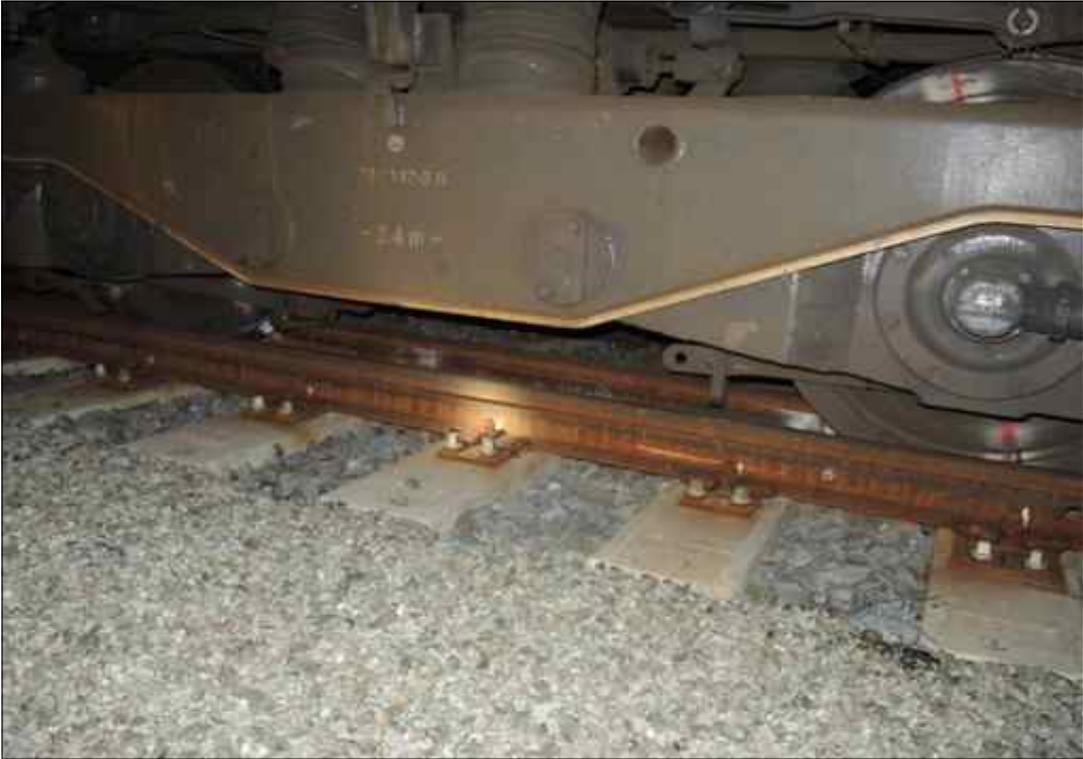
Grade:	an incident.
Date and time:	12 th September 2017, 5:23 (3:23 GMT).
Occurrence type:	damage of the overhead contact line.
Description:	overburning of the overhead contact line over the standing rolling stocks.
Type of train:	standing rolling stocks (preparation for the regional passenger train No. 8811).
Location:	Beroun station, the station track no. 5, km 38,865.
Parties:	SŽDC, s. o. (IM); ČD, a. s. (RU of the standing rolling stocks).
Consequences:	0 fatalities, 0 injuries; total damage CZK 1 557,-
Direct cause:	<ul style="list-style-type: none">• overburning of the overhead contact line caused by its heating when the traction current passed in contact with the contact strip of the contact strip collector.
Contributory factors:	<ul style="list-style-type: none">• separation of the overhead contact line into more separately switchable section due to construction works at Beroun station and also reducing of load capacity of the overhead contact line over the station lines;• uncompleted current interconnection between the 3rd and 5th station lines of Beroun station;• inadequate (galvanic) interconnection of the newly inserted switches which connect the circuit of the classification yard and the passenger station of Beroun station;• substitute interconnection of the removed rails on the line No. 95s and the station lines No. 213 - 219 made per ropes with insufficient cross-section;• technical defect of the expanding section insulator No. ÚPD 13v in km 38,455.
