The Rail Safety
Inspection Office

NIB ANNUAL REPORT 2017

according to Article 23(3) of Directive 2004/49/EC

September 2018

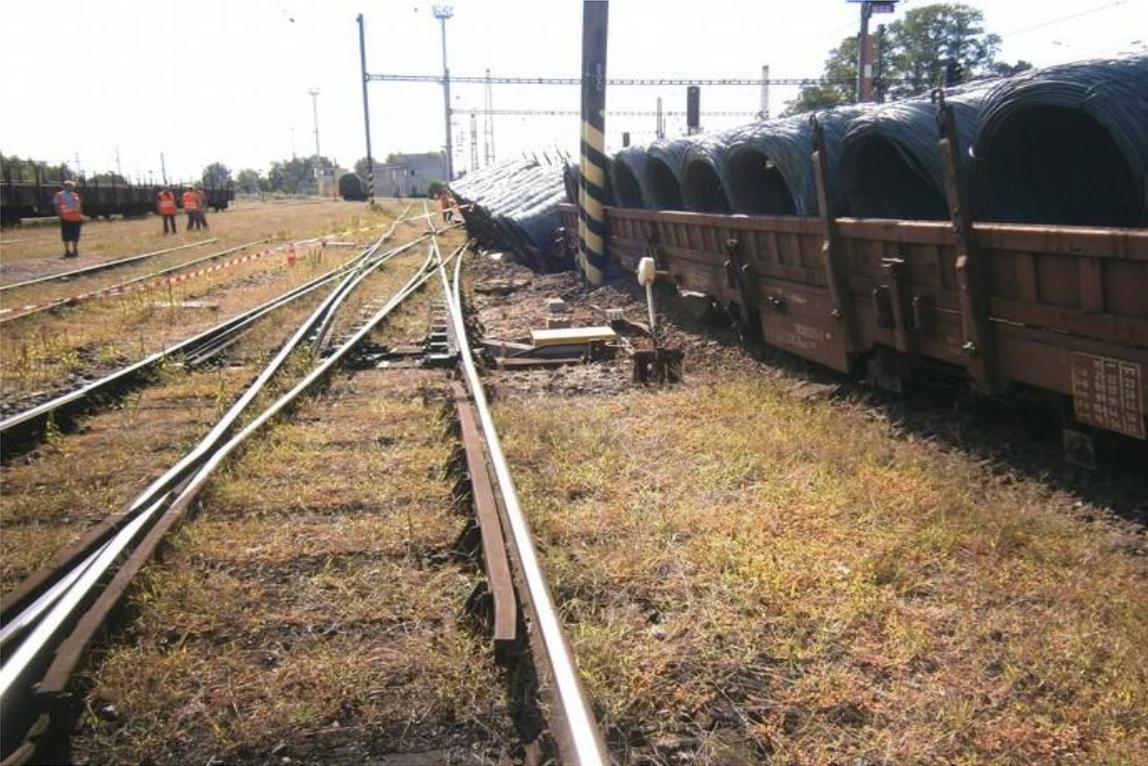
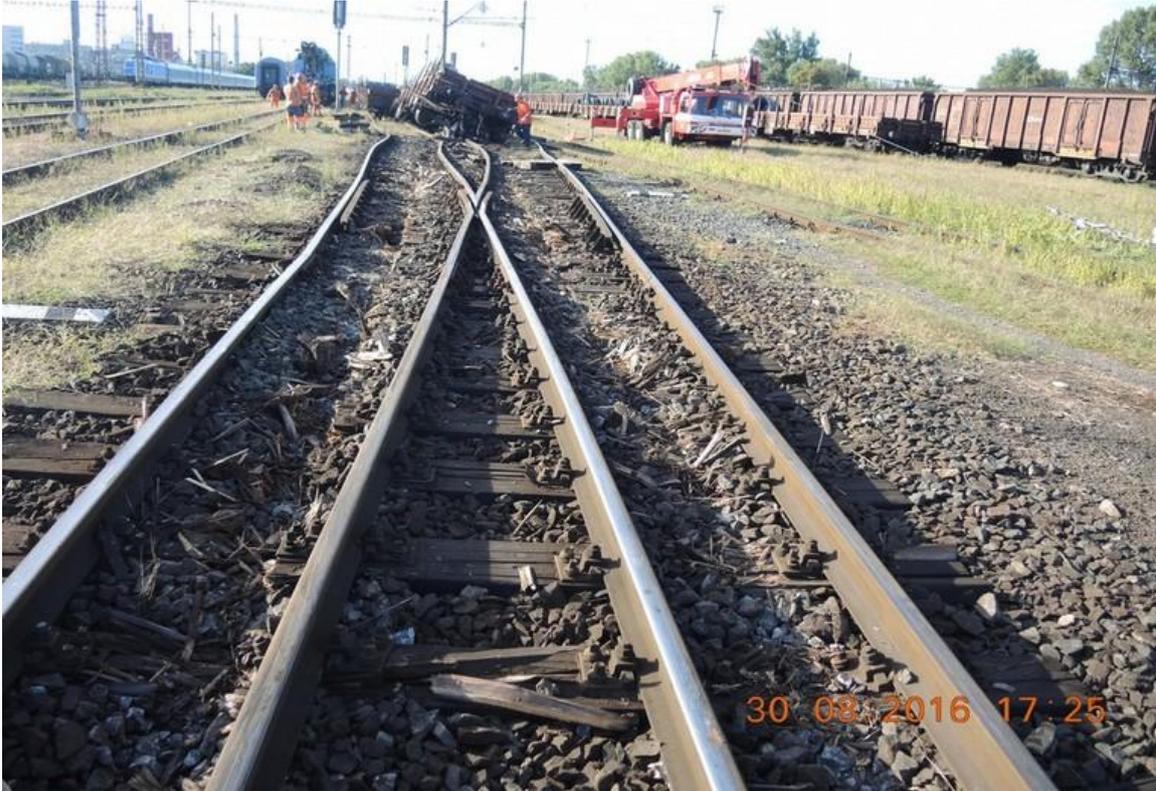
Grade:	a serious accident.
Date and time:	30 th August 2016, 7.23 (5.23 GMT).
Occurrence type:	a trains collision
Description:	an unauthorized movement of the regional passenger train No. 203 behind of a front track convergence marker and a consequent collision with the regional passenger train No. 204
Type of train:	the regional passenger train No. 203 the regional passenger train No. 204
Location:	Chválkov operating control point, a place of the unauthorized movement (km 30,408), a place of the trains collision an open line between Včelnička and Chávkov operating control points (km 30,244)
Parties:	Jindřichohradecké místní dráhy, a. s. (IM and RU of the regional passenger trains)
Consequences:	9 injuries (6 passengers, a conductor and a train driver of the regional passenger train No. 204 and a train driver of the regional passenger train No. 203); total damage CZK 12 220 997,-
Direct cause:	<ul style="list-style-type: none">• a failure to wait for an arrival of the train No. 204 to Chválkov operating control point and a departure of the train No. 203 from this operating control point.

- to ensure that the safety management system of all Czech infrastructure managers will be in line with Czech law and the Directive 2004/49/EU;
- to unify the technological processes for train drivers in order to eliminate as much as possible human error which could lead to an unauthorized departure of a train from any operating control point;
- to eliminate possible human errors which could lead to unauthorized departure of a train from any operation control point and a subsequent collision with another train by using the technical (safety) devices.

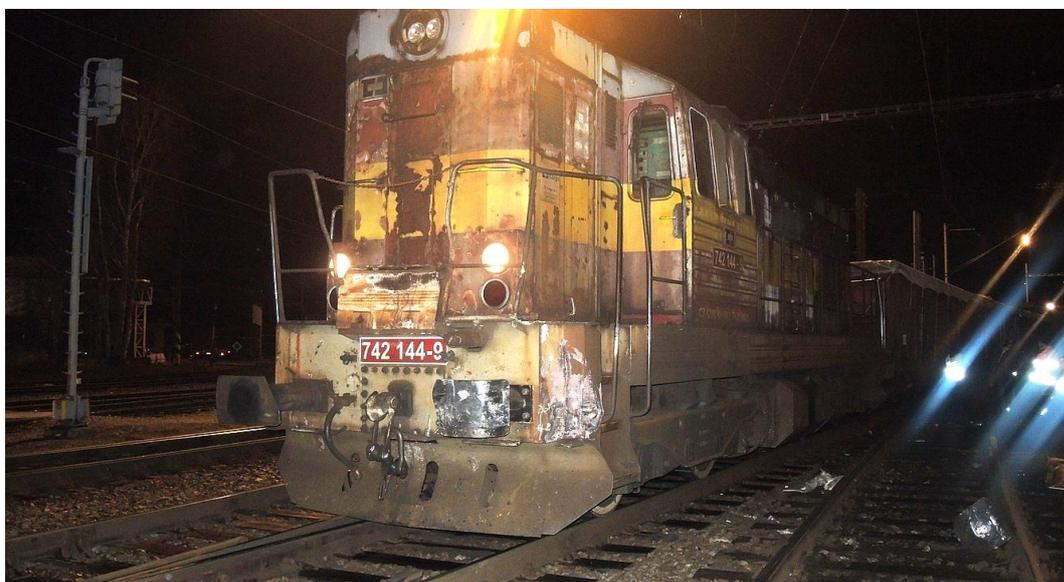
Grade:	incident.
Date and time:	4 th April 2017, 22:29 (21:29 GMT).
Occurrence type:	trains collision.
Description:	unauthorized movement of shunting operation (RU METRANS, a. s.) behind a signal device No. Se224, its entry into a route of shunting operation (RU IDS CARGO, a. s.) with consequent collision and derailment.
Type of train:	two shunting operations.
Location:	Ústí nad Labem hl. n. station (north district), signal device No. Se224, km 519,258; place of collision: between switches No. 239 and 241, km 519,362.
Parties:	SŽDC, s. o. (IM); IDS CARGO, a. s. (RU of the shunting operation); METRANS, a. s. (RU of the shunting operation).
Consequences:	0 fatalities, 0 injury; total damage CZK 4 362 291,-
Direct cause:	unauthorized movement of shunting operation (RU METRANS, a. s.) behind the signal device No. Se224 and its entry into a route of shunting operation (RU IDS CARGO, a. s.).
Contributory factor:	none.

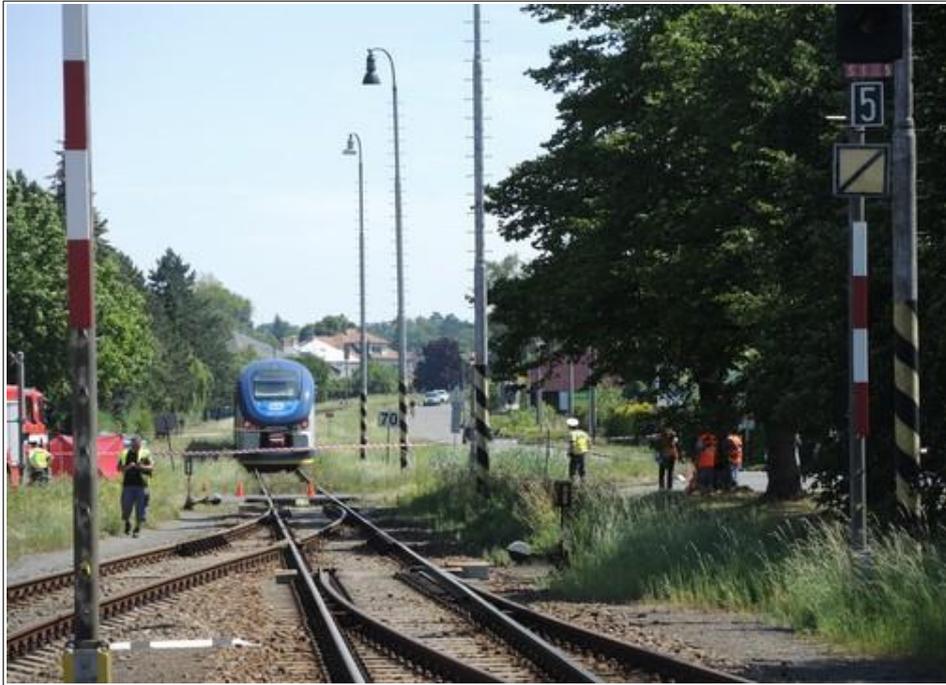
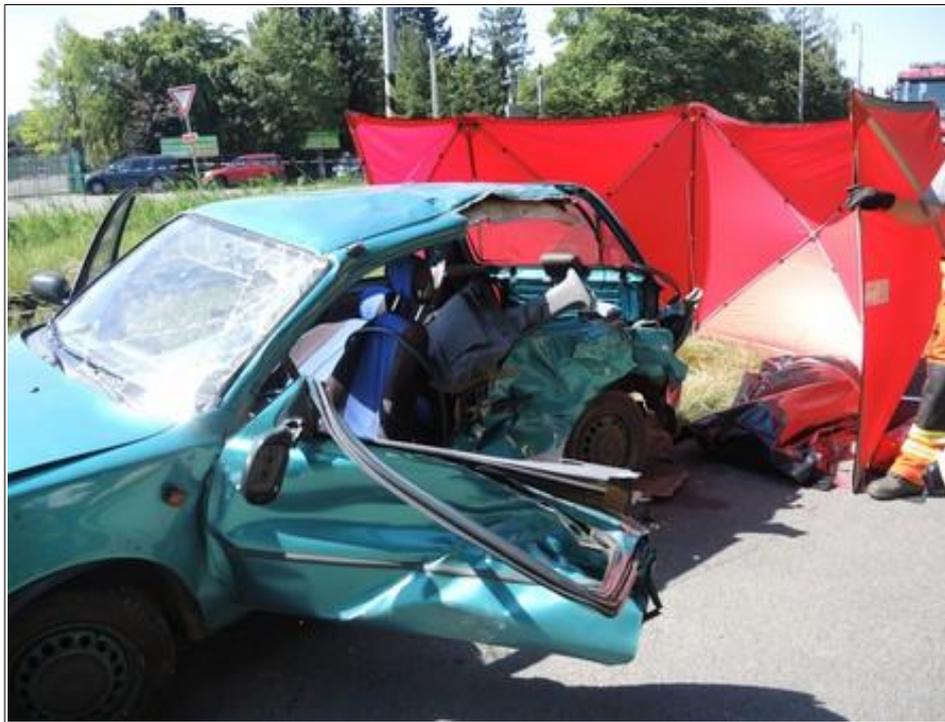
Grade:	accident.
Date and time:	27 th July 2017, 15:18 (13:18 GMT).
Occurrence type:	level crossing accident.
Description:	collision of freight train No. 68250 with a car at active level crossing No. P3652.
Type of train:	freight train No. 68250.
Location:	railway track Šatov st. hr. – Okříšky, Stařeč station, active level crossing No. P3652, km 161,719.
Parties:	SŽDC, s. o. (IM); ČD Cargo, a. s. (RU of the freight train No. 68250); driver of a car (level crossing user).
Consequences:	1 fatality (driver of the car); total damage CZK 143 422,-
Direct cause:	<ul style="list-style-type: none">• driver's failure to respect the light and acoustic warning and driving across the level crossing at the time when it was forbidden and visual and acoustic warnings were being given.
Contributory factor:	none.
Underlying cause:	<ul style="list-style-type: none">• insufficient attention during driving the car, that caused oversight of traffic signs in front of the level crossing and failure to register acoustic and visual warnings of the level crossing safety equipment system.
