**The Rail Safety
Inspection Office**

NIB ANNUAL REPORT 2020

The Rail Safety Inspection Office

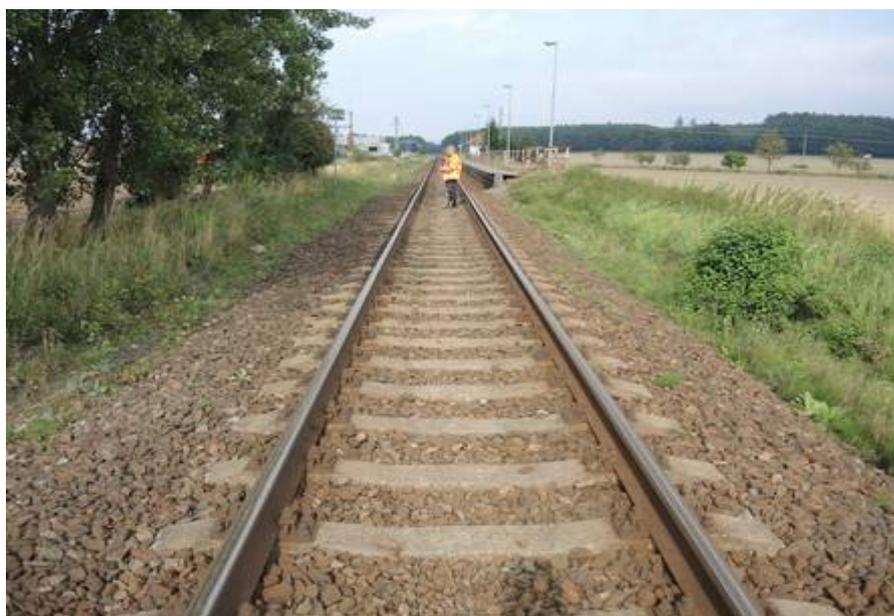
Grade:	an accident.
Date and time:	6 th September 2017, 12:26 (10:26 GMT).
Occurrence type:	an accident to a person caused by a rolling stock in motion.
Description:	the collision of the long distance passenger train No. 925 with the external worker.
Type of train:	the long distance passenger train No. 925.
Location:	an open line between Jaroměř and Česká Skalice stations, km 9,171.
Parties:	SŽDC, s. o. (IM); ČD, a. s. (RU of the long distance passenger train No. 512); the external worker.
Consequences:	1 injury; total damage CZK 0,-
Direct cause:	<ul style="list-style-type: none">• unauthorized entrance of the external worker into the structure gauge of the open line track while the train was moving.
Contributory factor:	none.
Underlying cause:	<ul style="list-style-type: none">• inattention of the external worker when he left a work place due to a phone call.
Root cause:	none.
Recommendation:	none.

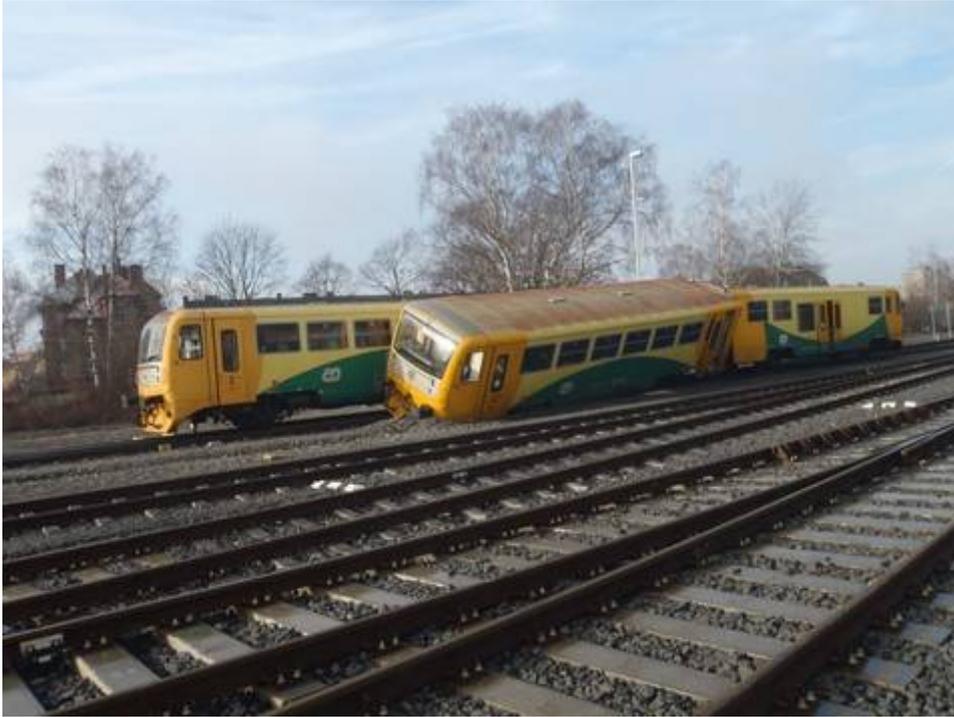
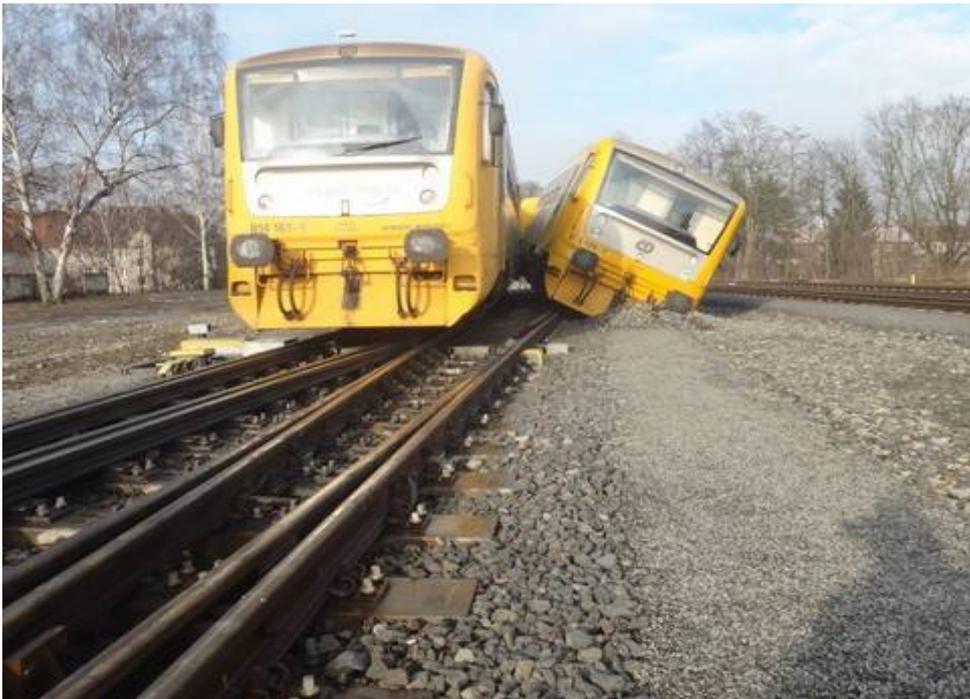
- Grade: an incident.
- Date and time: 6th January 2018, 0.04 (5th January 23:04 GMT).
- Occurrence type: a trains collision.
- Description: an unauthorized movement of the shunting operation behind the signal device Se16 and its consequent collision with the train set No. 6095 and derailment.

- Consequences: 0 fatality, 0 injury;
total damage CZK 3 365 233,-
- Direct cause:
- a shunting operation driver's error (he did not respect the signal „Shunting forbidden” of the shunting signal device Se16).

- we recommend that NSA adopt measures that the participating IMs and RUs will ensure an increase of the control activities over compliance with the established rules for organization and carrying out the shunting operation, including the radio communication.

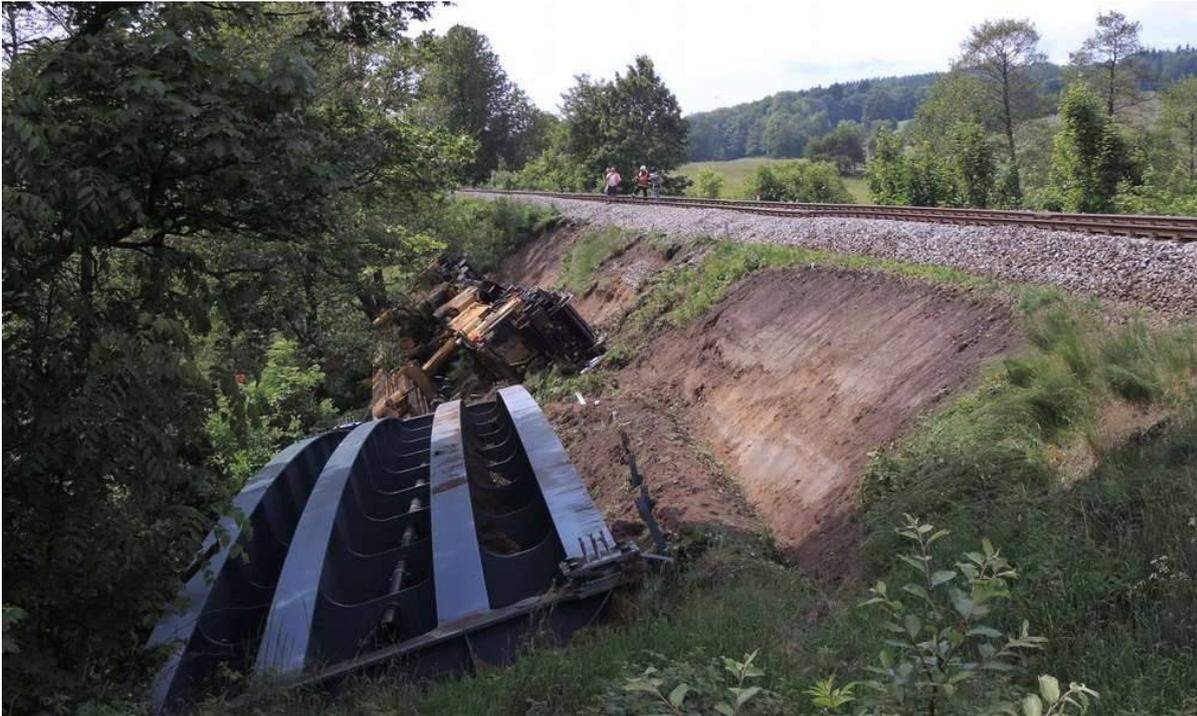
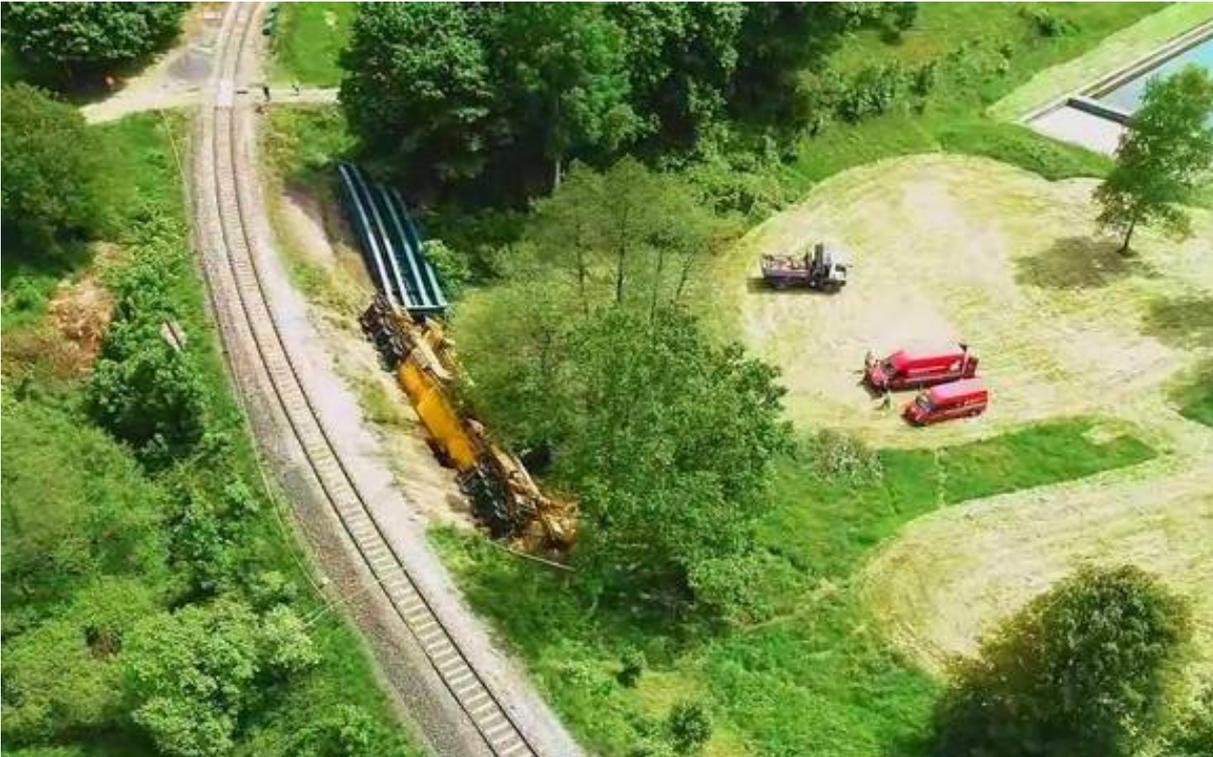
Grade:	a serious accident.
Date and time:	23 rd May 2018, 11:18 (9:18 GMT).
Occurrence type:	a train derailment.
Description:	the derailment of the rail-mounted crane with its rollover and fall from the railway embankment.
Type of train:	a shunting operation.
Location:	an open line between Mikulášovice dolní nádraží station and Panský operating control point, km 9,928.
Parties:	SŽDC, s. o. (the IM); GJW Praha, spol. s r. o. (the RU of the shunting operation); Chládek a Tintěra, Pardubice a. s. (a producer of a construction); FIRESTA-Fišer, rekonstrukce, stavby, a. s. (a producer of a construction).
Consequences:	0 fatality, 2 injuries; total damage CZK 26 971 845,-
Direct cause:	<ul style="list-style-type: none">• more than doubled excess of the permissible load on the track during transport of a bridge structure suspended on a jib of the rail-mounted crane which resulted in the right track level fall and the rail-mounted crane rollover.

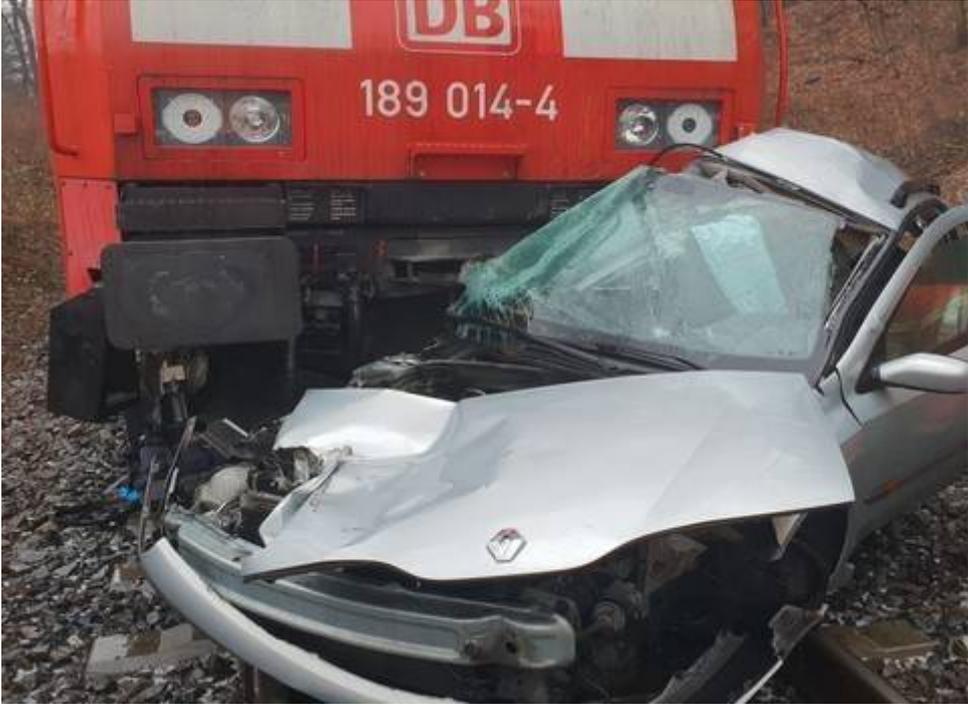
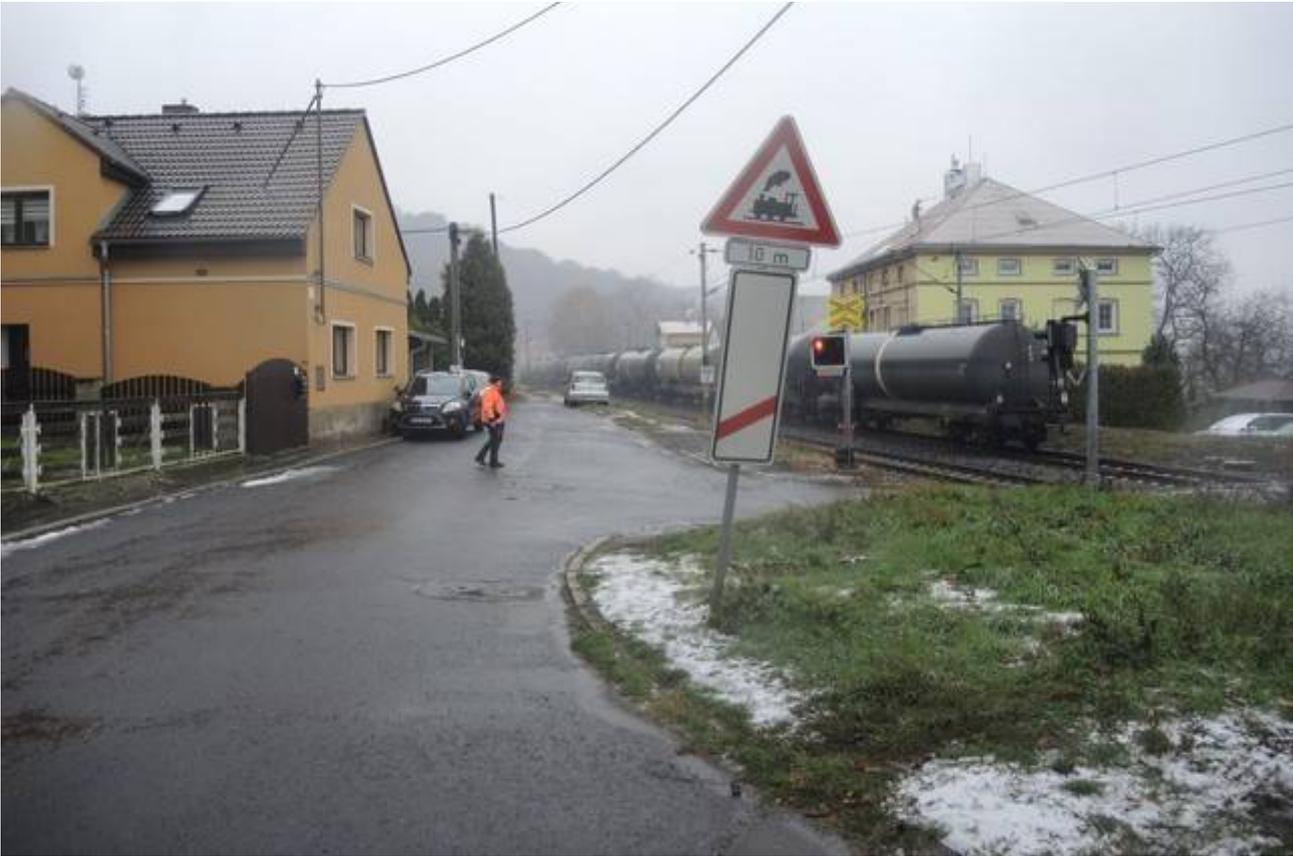
Grade:	accident.
Date and time:	2 nd December 2018, 10:18 (9:18 GMT).
Occurrence type:	level crossing accident.
Description:	collision of the freight train No. 55383 with a car at the level crossing No. P2969.
Type of train:	the freight train No. 55383.
Location:	open line between Velké Březno and Ústí nad Labem-Střekov stations, the level crossing No. P2969, km 434,211.
Parties:	SŽDC, s. o. (IM); ARRIVA vlaky, s. r. o. (RU of the freight train No. 55383); driver of the car (level crossing user).
Consequences:	1 fatality; total damage CZK 2 715 500,-
Direct cause:	<ul style="list-style-type: none">• driver's failure to respect the light and acoustic warning and driving across the level crossing at the time when it was forbidden and visual and acoustic warnings were being given.
Contributory factor:	none.
Underlying causes:	<ul style="list-style-type: none">• driver's failure to respect of the light and sound warning and ride at the level crossing at the time when it was forbidden;• behavior of the driver in front of the level crossing, the car driver wasn't careful enough.

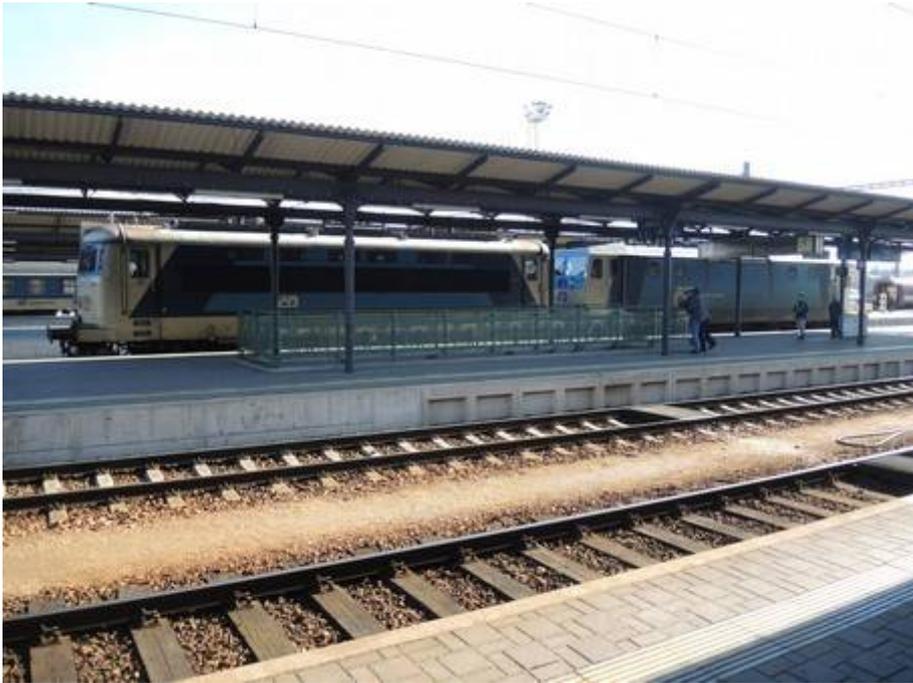
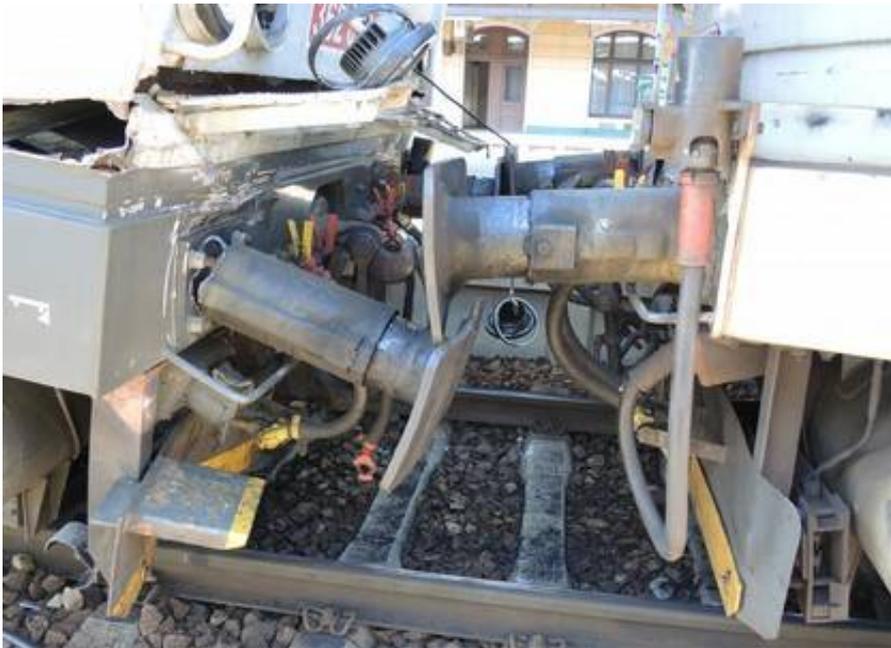
- Grade: a serious accident.
- Date and time: 23rd February 2019, 5:42 (4:42 GMT).
- Occurrence type: a train collision.
- Description: the collision of two locomotives during the shunting operation.

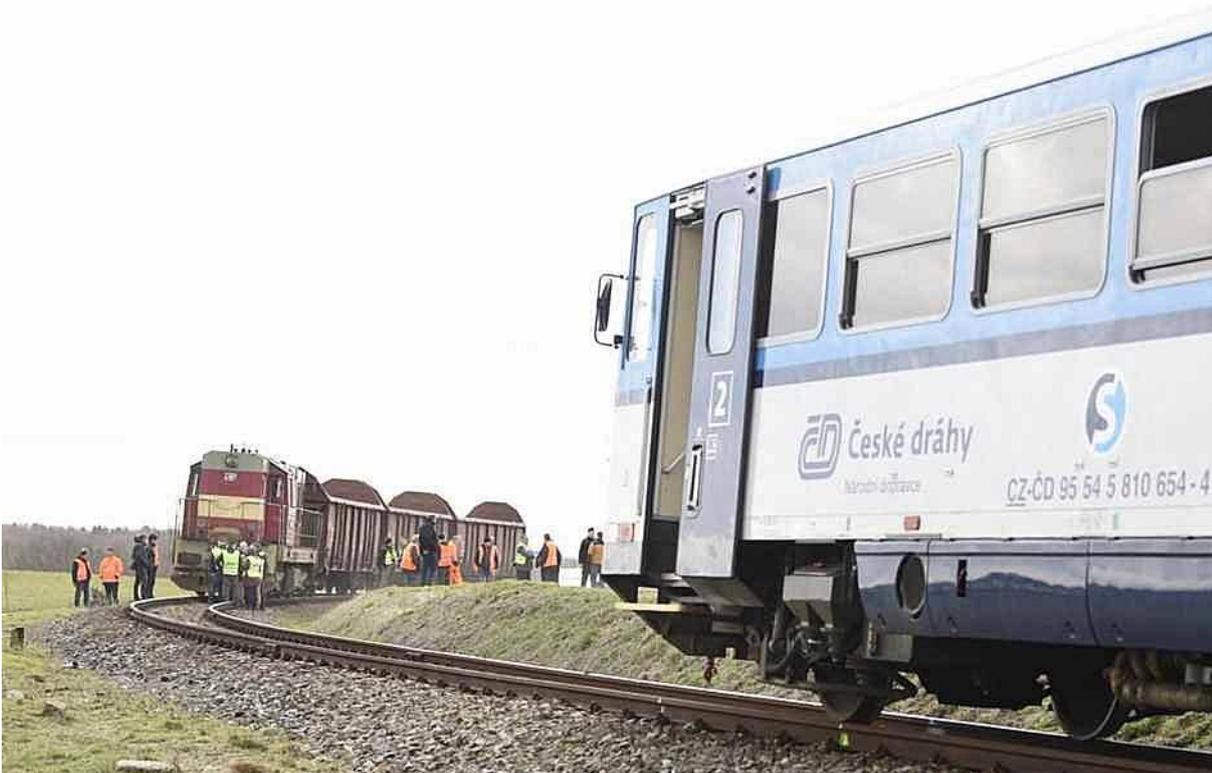
- Grade: a serious accident.
- Date and time: 4th March 2019, 12:19 (10:19 GMT).
- Occurrence type: a train collision.
- Description: an unauthorized departure of the regional passenger train No. 15912 from Ronov nad Doubravou operating control point and its consequent collision with the freight train No. 84261.

- considering the possibility that the ERTMS may not be implemented on some lines even in the long terms, the RSIO recommends to consider excluding them from the system covered by the requirements of the Directive on the interoperability of the rail system within the European Union and related European legislation, respectively to enable the implementation of the technical equipment that would enable to increase the safety level of movement of the railway vehicles by a technical solution adequate to the current state of the art and at the same time economically acceptable at an adequate level of safety on these lines.

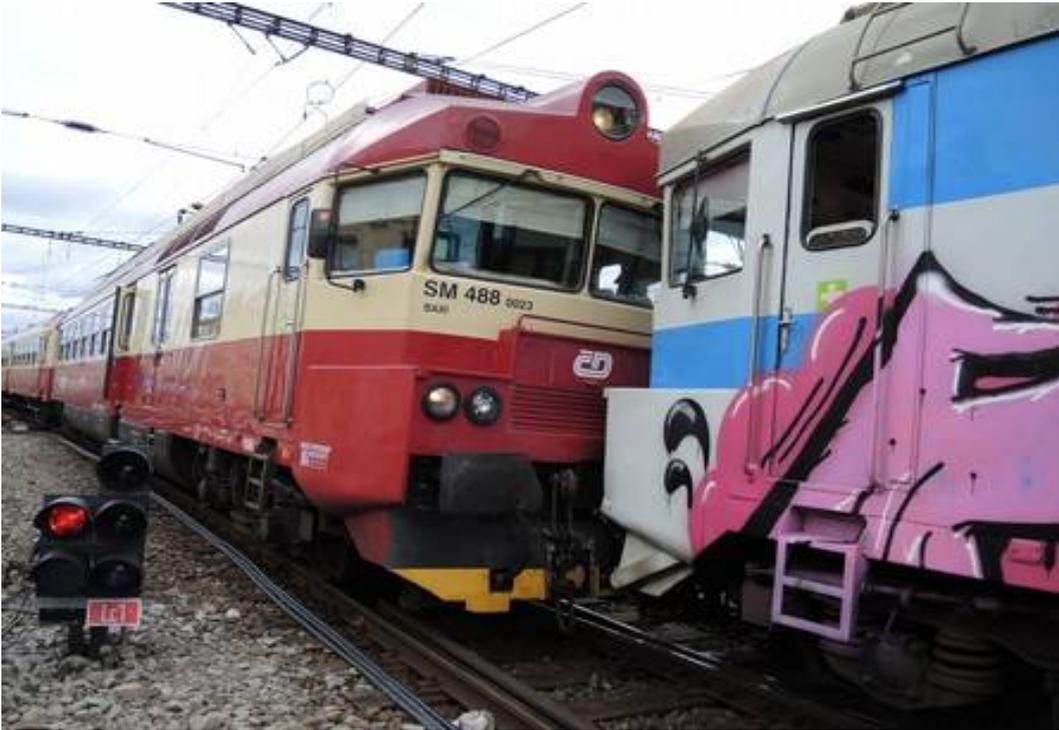
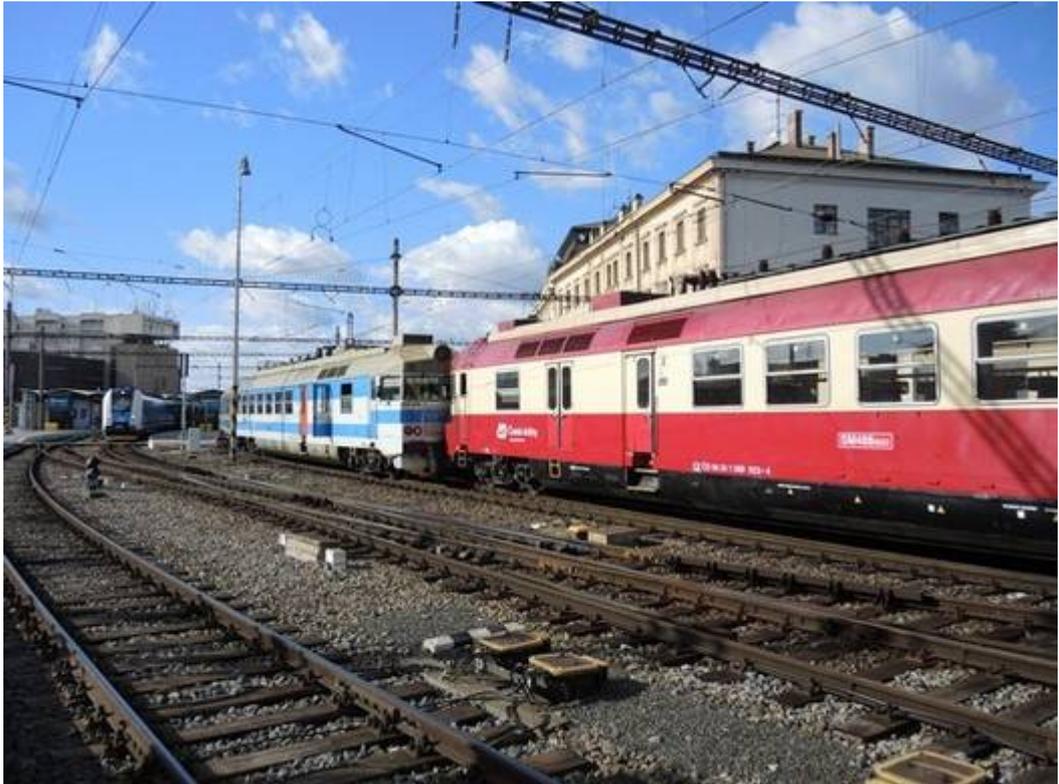
Grade:	serious accident.
Date and time:	5 th March 2019, 8:00 (7:00 GMT).
Occurrence type:	trains collision.
Description:	unauthorized movement of the regional passenger train No. 4708 behind the signal device Lc4 with consequent collision with oncoming the regional passenger train No. 4711.
Type of train:	the regional passenger trains No. 4708 and 4711.
Location:	Brno hl. n. station, station track No. 4, main route signal device Lc4, km 143,531; Place of the trains collision was on station track No. 4, km 143,570.
Parties:	SŽDC, s. o. (IM); ČD, a. s. (RU of the regional passenger trains No. 4708 and 4711).
Consequences:	23 injuries; total damage CZK 452 393,-
Direct cause:	<ul style="list-style-type: none">operational error of the train driver of the regional passenger train No. 4708 (he did not respect the signal „Stop” of the main route signal device Lc4).
Contributory factor:	<ul style="list-style-type: none">absence of technical equipment which prevents a train from passing a signal in case of danger.

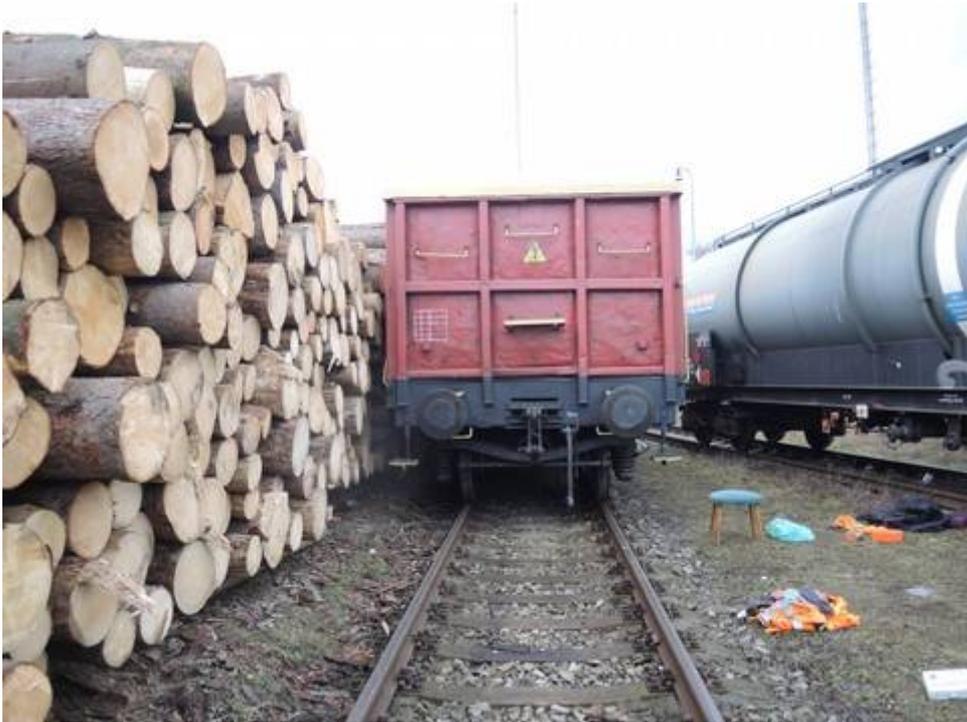
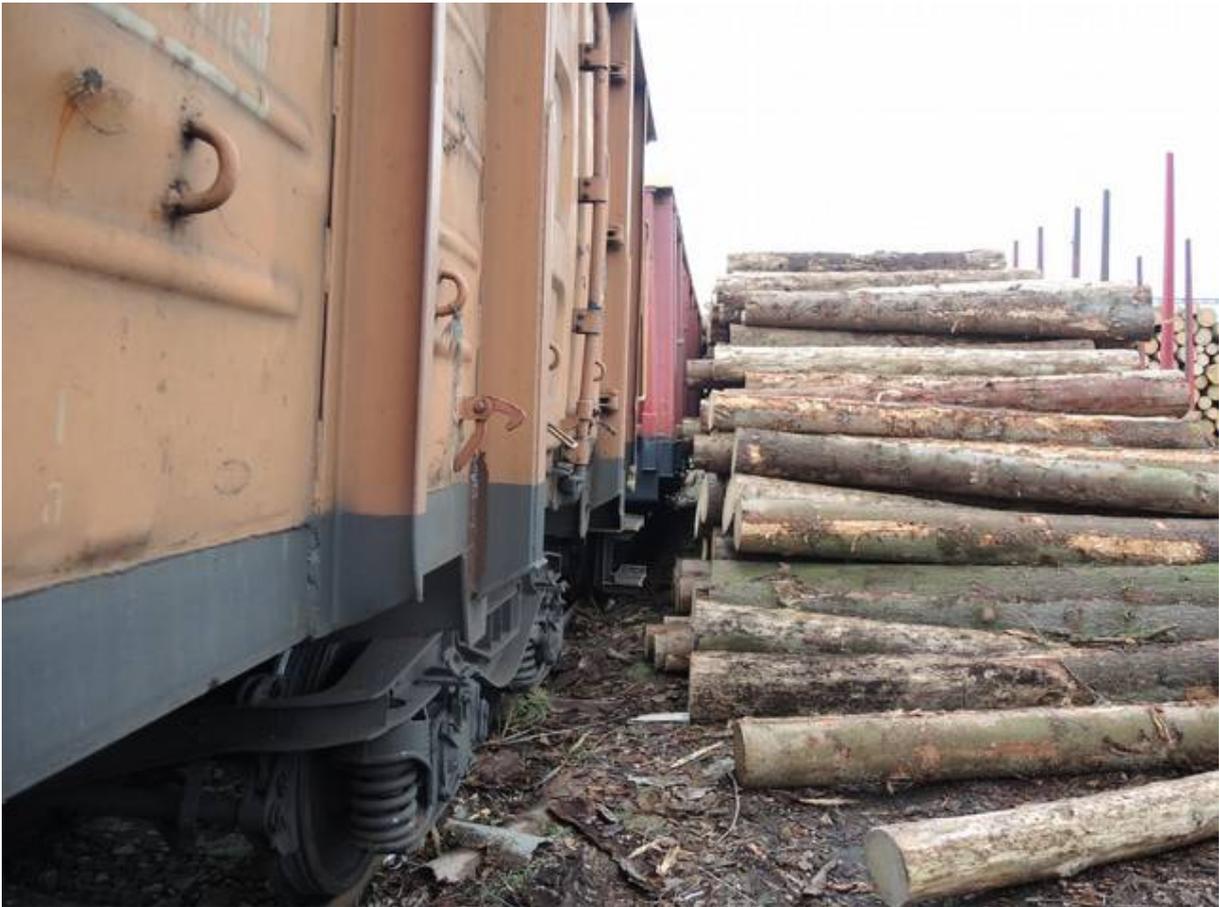
Grade:	incident.
Date and time:	11 th March 2019, 8:25 (7:25 GMT).
Occurrence type:	unsecured movement.
Description:	unsecured movement of the freight train No. 62502 to station track No. 37, which was occupied by shunting operation.
Type of train:	the freight train No. 62502; the shunting operation.
Location:	Most nové nádraží station, station track No. 37, light signal device Lc37, km 2,826.
Parties:	SŽDC, s. o. (IM); ČD Cargo, a. s. (RU of the freight train No. 62502 and the shunting operation).
Consequences:	0 fatality, 0 injury; total damage CZK 0,-
Direct cause:	<ul style="list-style-type: none">not ended of interlocking shunting and failure to detection of unoccupied train route for ride of the freight train No. 62502.
Contributory factor:	<ul style="list-style-type: none">cancellation of authority for shunting from interlocking plant No. 5 on station track No. 37 to interlocking plant No. 1 by the station dispatcher of interlocking plant No. 1 through signalling plant control without telephone communication with station dispatcher of interlocking plant No. 5.

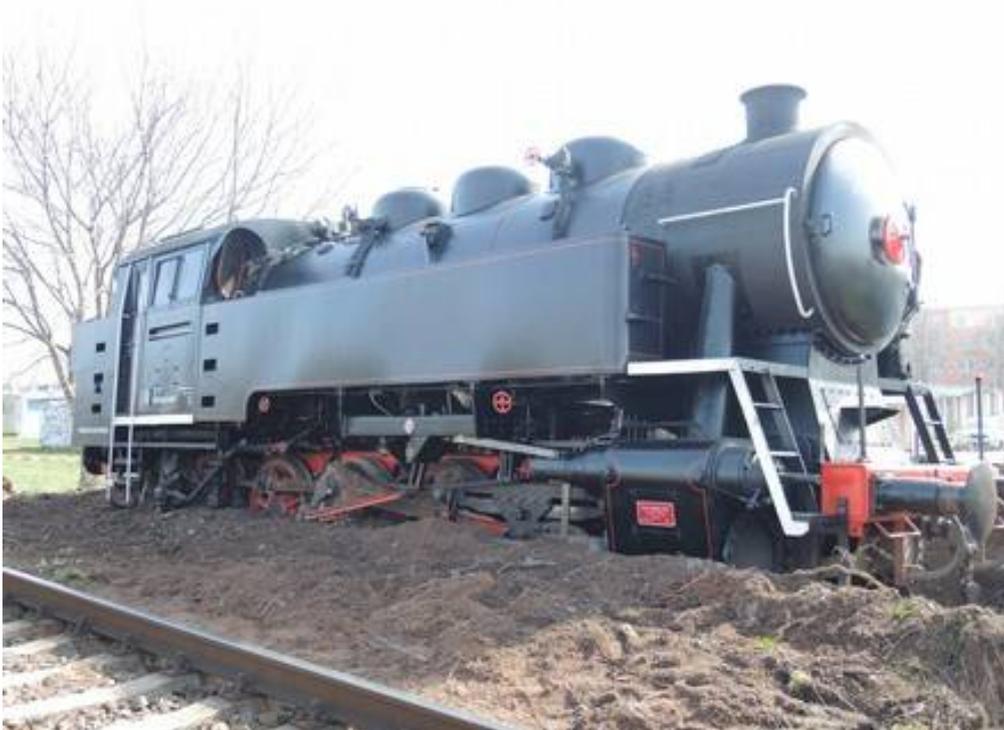
- Grade: an incident.
- Date and time: 29th March 2019, 10:51 (8:51 GMT).
- Occurrence type: a train derailment.
- Description: the derailment of the freight train No. 83306 (the solo running locomotive).

- we recommend that the NSA adopt own measures to ensure the implementation of the above safety recommendations for other relevant steam locomotive operators in the Czech Republic.

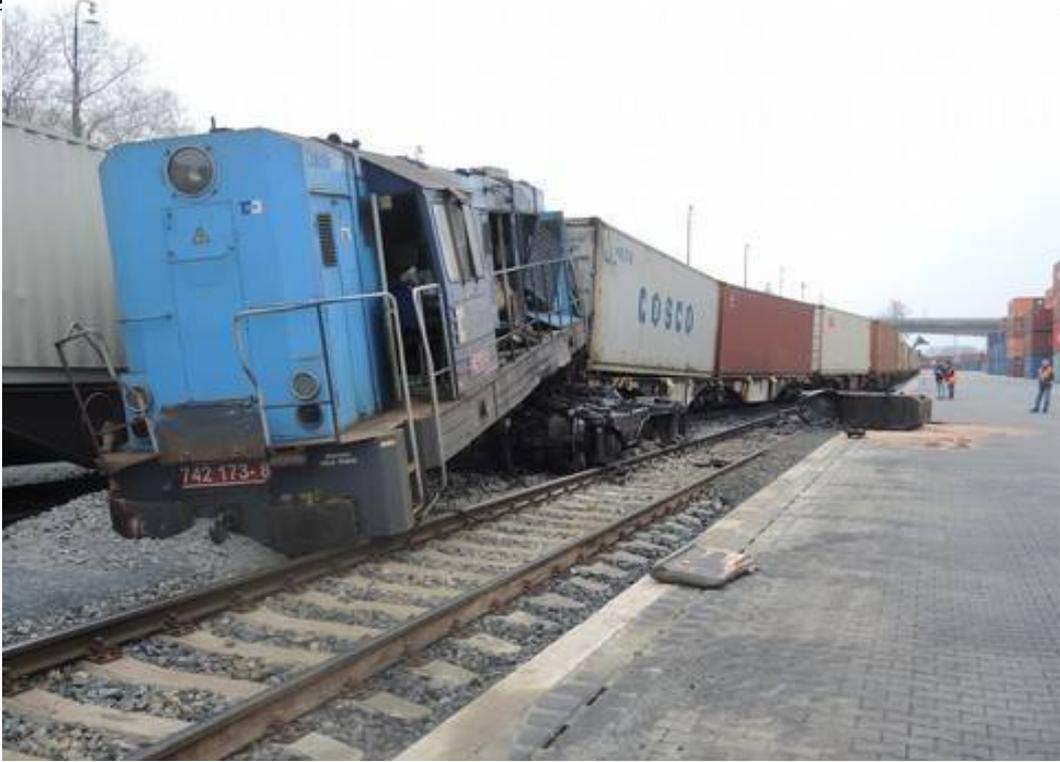
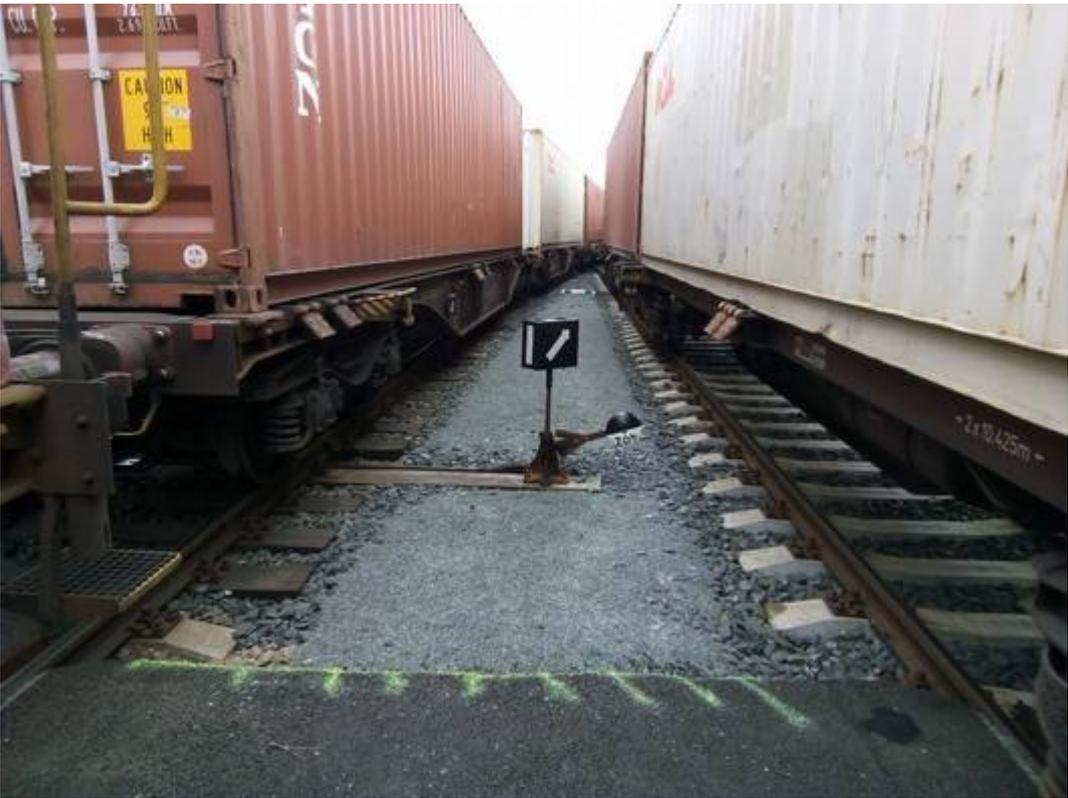
Grade:	serious accident.
Date and time:	13 th April 2019, 5:37 (3:37 GMT).
Occurrence type:	trains collision.
Description:	unsecured movement of the shunting operation with consequent collision with detached rolling stocks, derailment of four rolling stocks and fire.
Type of train:	the shunting operation; detached rolling stocks.
Location:	Vlečka – přístav Mělník siding, switch No. 402, km 0,761; place of collision was at switch No. 403, km 0,793; place of derailment was at km 0,795.
Parties:	České přístavy, a. s. (IM); ČD Cargo, a. s. (RU of the shunting operation).
Consequences:	1 injury; total damage CZK 19 380 241,-
Direct cause:	<ul style="list-style-type: none">• incorrectly setting of shunting route.
Contributory factors:	<ul style="list-style-type: none">• failure to comply running at sight among others by not adjusting the speed of the shunting operation;• failure to tracking of the signals and failure to acting on the basis of finding facts.

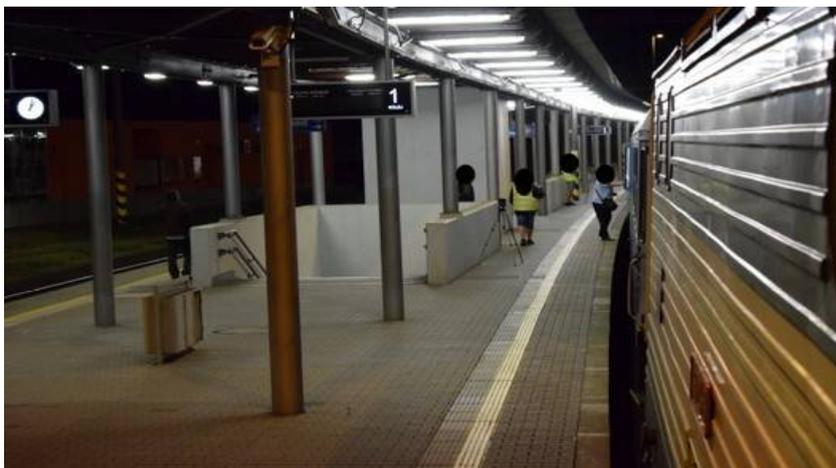
Grade:	an accident.
Date and time:	19 th April 2019, 1:57 (18 th April, 23:57 GMT).
Occurrence type:	an accident to a person caused by a rolling stock in motion.
Description:	the disembarkation of the passenger from the moving regional passenger train No. 5021, his fall into the track and the consequent collision with the freight train No. 59099.
Type of train:	the regional passenger train No. 5021; the freight train No. 59099.
Location:	Ústí nad Orlicí station, the station track No. 1, km 256,510.
Parties:	SŽDC, s. o. (IM); ČD, a. s. (RU of the regional passenger train No. 5021); Unipetrol doprava, s. r. o. (RU of the freight train No. 59099).
Consequences:	1 fatality; total damage CZK 0,-
Direct causes:	<ul style="list-style-type: none">• the passenger's effort to get off the moving regional passenger train No. 5021 at the platform area;• behavior of the train conductor who permitted departure of the regional passenger train No. 5021 with the unclosed boarding door.

Contributory factor:	<ul style="list-style-type: none">• the effect of alcohol on behavior of the passenger.
Underlying causes:	<ul style="list-style-type: none">• the risky behavior of the passenger who did not follow the legal regulations and the contractual conditions of carriage of the RU;• failure to ensure the technological procedures of the RU by the train conductor of the regional passenger train No. 5021 when performing the procedures for the train departure from Ústí nad Orlicí station.
Root cause:	none.
Recommendation:	not issued.

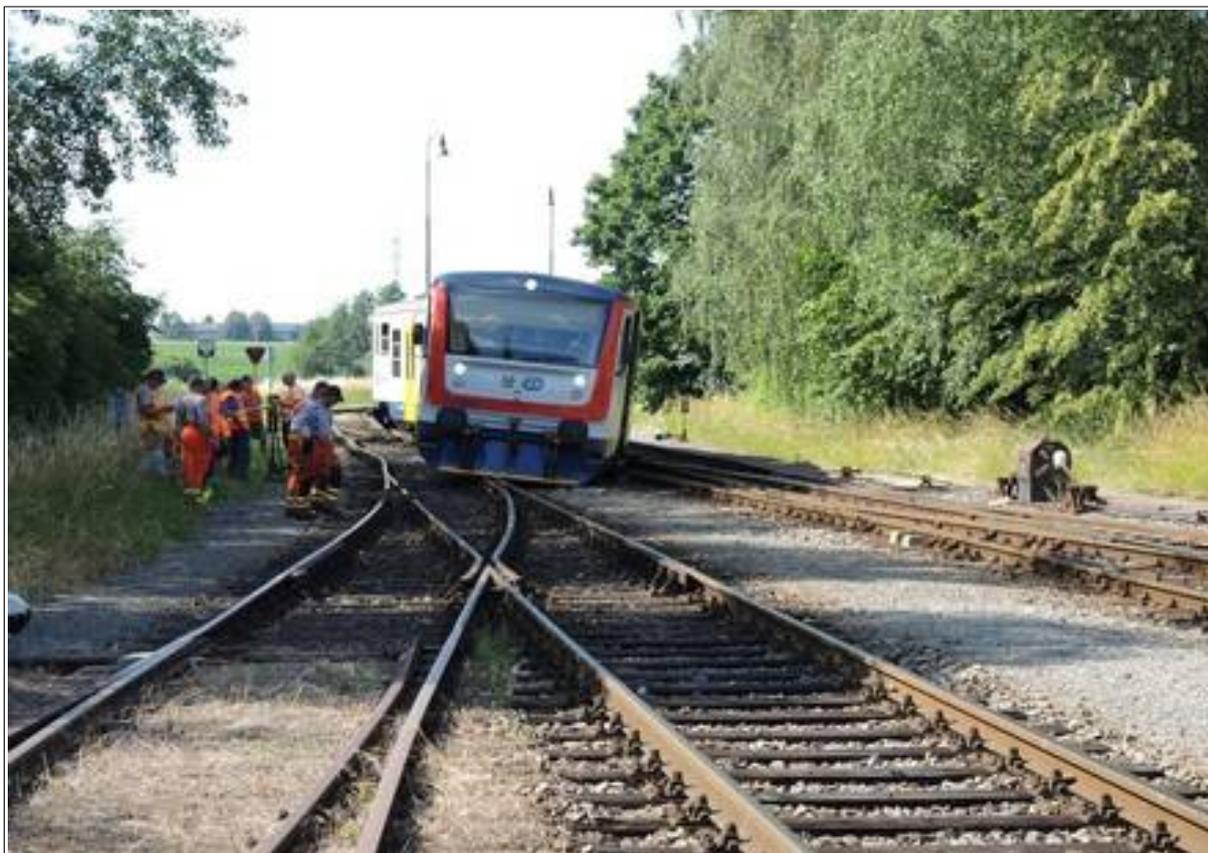
Grade: an incident.
Date and time: 28th June 2019, 12:51 (11:51 GMT).
Occurrence type: a train derailment.
Description: the unsecured movement of the regional passenger train No. 15048 with the consequent derailment.
Type of train: the regional passenger train No. 15048.
Location: Vysoké Mýto operational control point, the switch No. 1, km 7,489; a place of the derailment is at the switch No. 1, km 7,494.
Parties: SŽDC, s. o. (IM);
ČD, a. s. (RU of the regional passenger train No. 15048);
Consequences: 0 fatality, 0 injury;
total damage CZK 454 361,-

- we recommend that the NSA adopt its own measures to ensure that the existing valve of the rescue brake which is situated in the driver's cab will be removed from the right side of the control panel or the duplicit valve of the rescue brake will be established at such place, where it could be used by another person in the driver's cab who will sit on the rescue seat or will state next to the train driver. This should be adopt for the rail vehicles series 814 and 914.

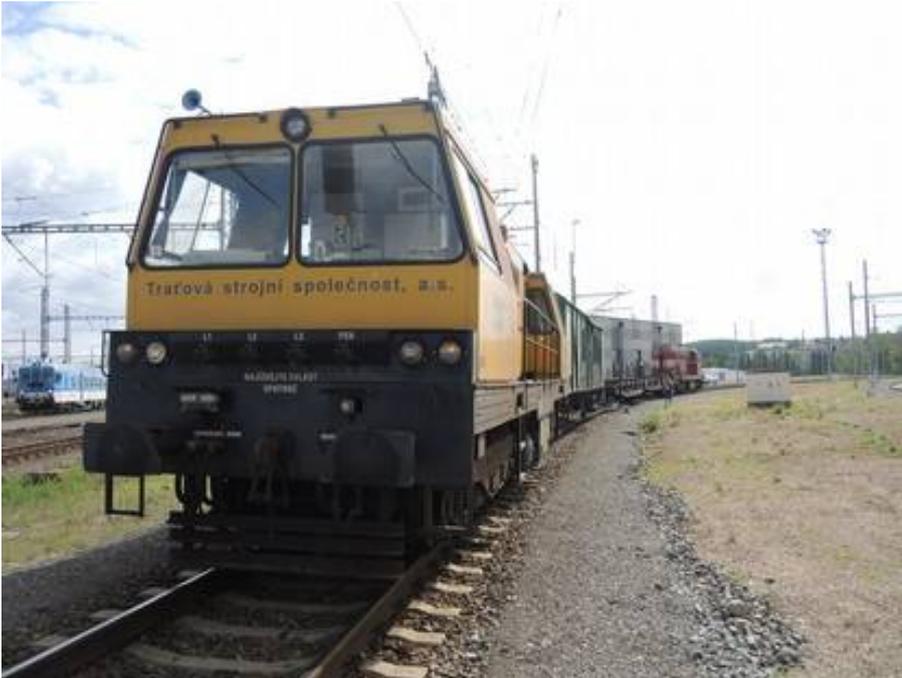
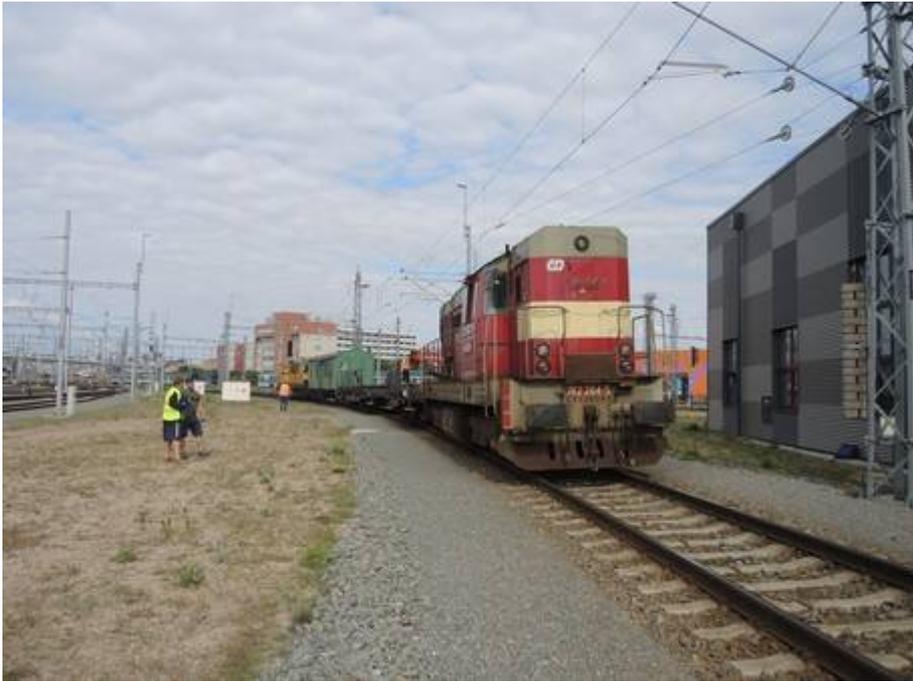
Grade:	incident.
Date and time:	8 th July 2019, 7:00 (5:00 GMT).
Occurrence type:	trains collision.
Description:	collision of the shunting operation with the service train No. 55862.
Type of train:	the service train No. 55862; the shunting operation.
Location:	Plzeň hl. n. station, station track No. 921, km 348,415.
Parties:	SŽDC, s. o. (IM); Traťová strojní společnost, a. s. (RU of the service train No. 55862); ČD, a. s. (RU of the shunting operation).
Consequences:	0 fatality, 0 injury; total damage CZK 298 180,-
Direct cause:	<ul style="list-style-type: none">• failure to stop the shunting operation in front of the service train No. 55862 at running at sight.
Contributory factor:	<ul style="list-style-type: none">• unauthorized set the shunting operation in motion without instruction of the shunting supervisor to start of shunting;• incorrectly issued an instruction through the radio station and consequent unauthorized turn on the signal „Shunting permitted” at the signal device Lc204;• design of locomotive 742 series – the train driver has limited view of the track while driving a long part of locomotives forward.

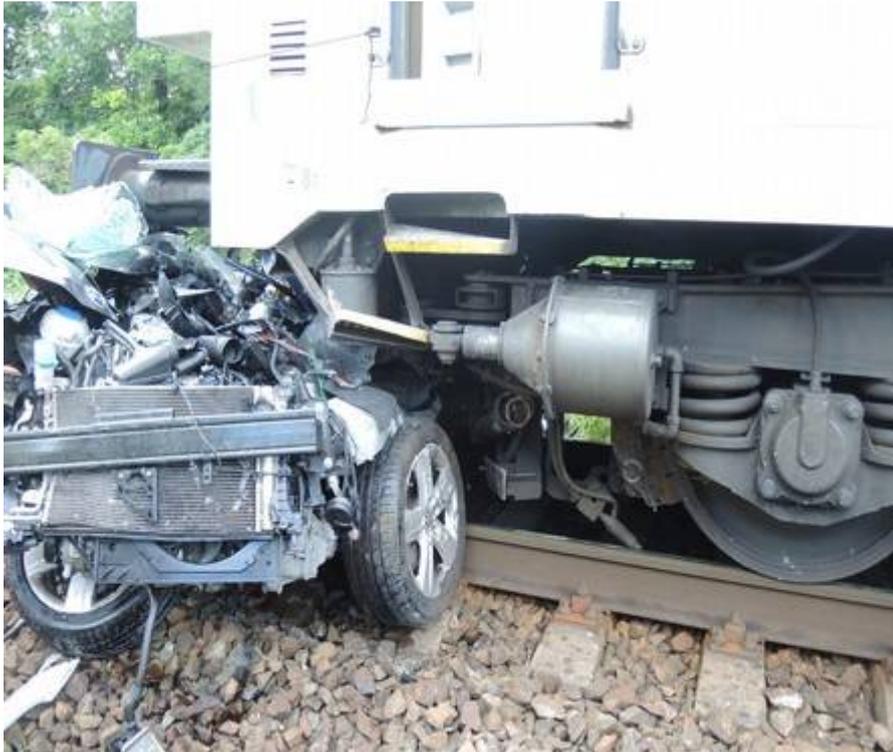
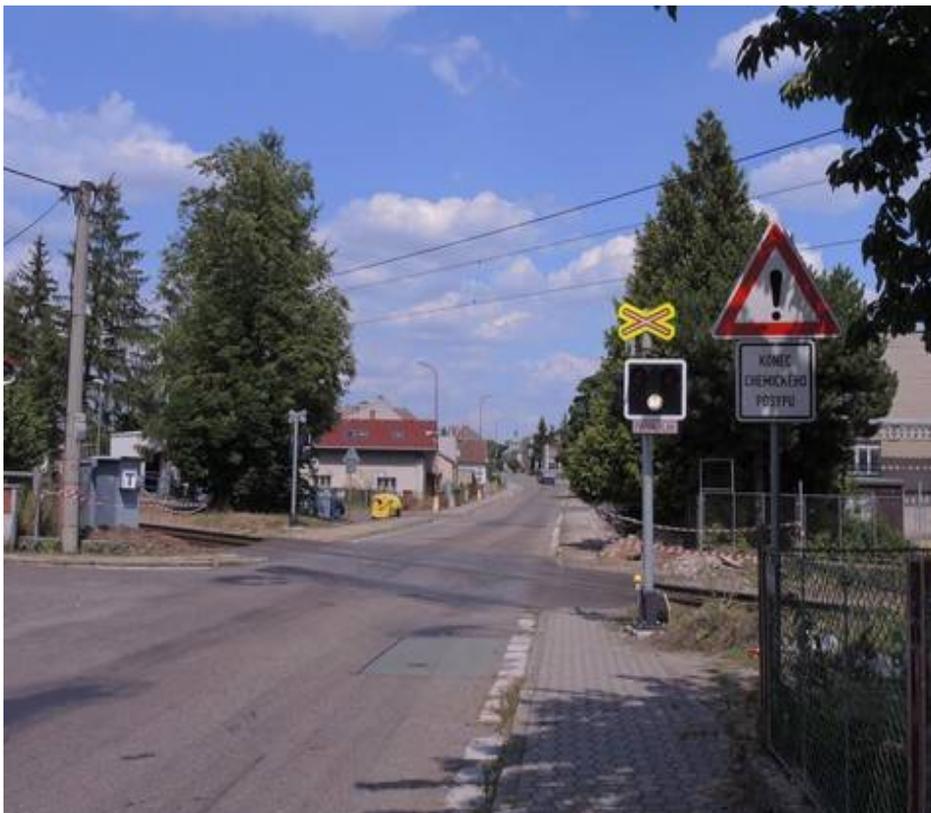
Grade:	accident.
Date and time:	14 th July 2019, 14:52 (12:52 GMT).
Occurrence type:	level crossing accident.
Description:	collision of the regional passenger train No. 1793 with a car at the level crossing.
Type of train:	the regional passenger train No. 1793.
Location:	open line between Jaroměř and Smiřice stations, the level crossing No. P5223, km 35,068.
Parties:	SŽDC, s. o. (IM); ČD, a. s. (RU of the regional passenger train No. 1793); driver of the car (level crossing user).
Consequences:	4 fatalities, 0 injury; total damage CZK 450 550,-
Direct cause:	<ul style="list-style-type: none">• driver's failure to respect the light and acoustic warning and driving across the level crossing No. P5223 at the time when it was forbidden and visual and acoustic warnings were being given.
Contributory factor:	none.
Underlying causes:	<ul style="list-style-type: none">• driver's failure to respect of the light and sound warning and ride at the level crossing at the time when it was forbidden;• behavior of the driver in front of the level crossing, the car driver wasn't careful enough.

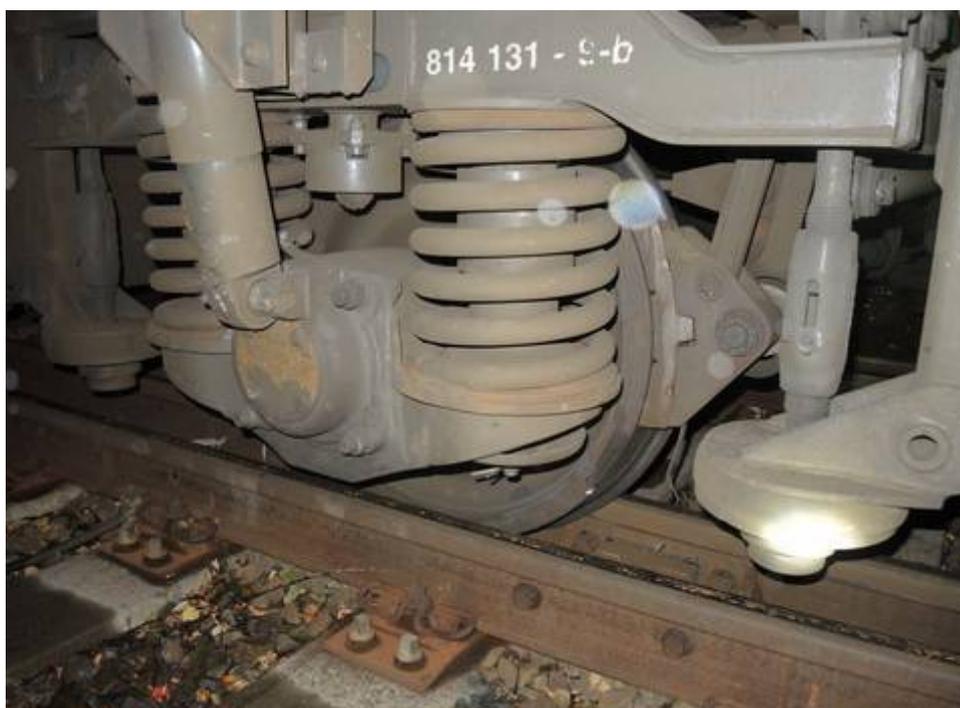
Grade:	incident.
Date and time:	2 nd October 2019, 18:00 (17:00 GMT).
Occurrence type:	train derailment.
Description:	unsecured movement of the regional passenger train No. 18809 with consequent derailment.
Type of train:	the regional passenger train No. 18809.
Location:	railway track Horní Dvořiště state border – České Budějovice, Omlenice station, switch No. 1, km 79,550.
Parties:	SŽDC, s. o. (IM); ČD, a. s. (RU of the regional passenger train No. 18809).
Consequences:	0 fatality, 0 injury; total damage CZK 89 381,-
Direct cause:	<ul style="list-style-type: none">• change of position of the switch No. 1, when the rolling stocks of the train No. 18809 were on the switch.
Contributory factor:	none.
Underlying cause:	<ul style="list-style-type: none">• failure to comply of technological procedures of the IM at cancellation and preparation of the train route.
Root cause:	none.
Recommendation:	not issued.
