The Rail Safety
Inspection Office

NIB ANNUAL REPORT 2016

according to Article 23(3) of Directive 2004/49/EC

September 2017

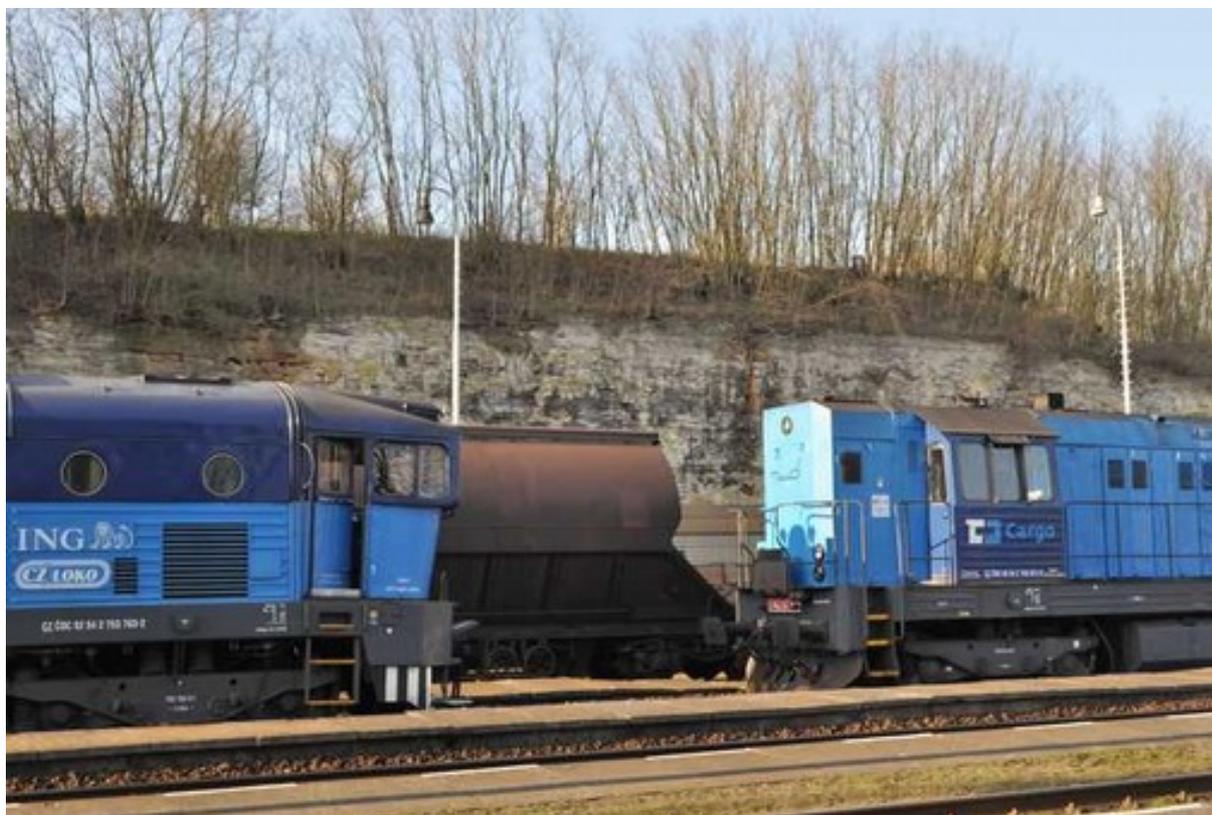
Grade:	serious accident.
Date and time:	28 th March 2015, 8:38 (7:38 GMT).
Occurrence type:	train collision.
Description:	the freight train No. 148359 passed the signal device No. S1 with the signal "Stop" on it and entered the track occupied by another the freight train No. 53668.
Type of train:	freight train No. 148359; freight train No. 53668.
Location:	open line between Velké Žernoseky a Litoměřice dolní nádraží stations, track line No. 1, km 411,153.
Parties:	SŽDC, s. o. (IM); ČD Cargo, a. s. (RU of both freight trains).
Consequences:	1 injury (train driver of the freight train No. 148359); total damage CZK 24 488 311,-
Direct cause:	<ul style="list-style-type: none">• unauthorized movement of freight train No 148359 into the section between Žernoseky and Litoměřice stations occupied by oncoming train No. 53668.
Contributory factor:	<ul style="list-style-type: none">• the absence of technical equipment that would prevent the train from passing signal at danger.

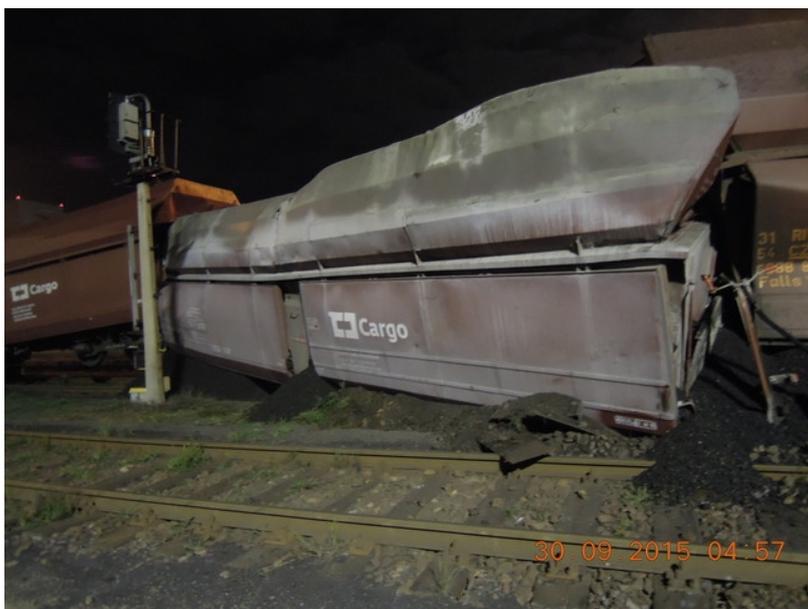
Grade:	a serious accident.
Date and time:	30 th October 2015, 4:57 (3:47 GMT).
Occurrence type:	a trains collision.
Description:	the unauthorized movement of the freight train No. 163602 behind the departure signal L2 and the consequent collision with the freight train No. 59040.
Type of train:	the freight train No. 163602; the freight train No. 59040.
Location:	the unauthorized movement: Řehlovice station, a station track No. 2, the departure signal L2, km 7,356; the trains collision: an open line between Řehlovice and Úpořiny stations, km 12,320.
Parties:	SŽDC, s. o. (IM); UNIPETROL DOPRAVA, s. r. o. (RU of the freight train No. 163602); SD - Kolejová doprava, a. s. (RU of the freight train No. 59040).
Consequences:	1 fatality (a train driver of the freight train No. 163602); total damage CZK 20 837 339,-
Direct cause:	the unauthorized movement of the freight train No. 163602 behind the departure signal device L2 with the signal “Stop” at Řehlovice station.

The purpose of the above safety recommendations is to allow, respectively to ensure more effective control activity for the train drivers focused on control of the radio connection test within the intention of the internal regulation SŽDC Z11, above mentioned should be done in cooperation between RU and IM, because the IM has a technical device which is able to record and to preserve information about the production of radio connection tests, and it can provide the sources for inspection activities to the RU in cases when the RU is not technically able to record these information. And so to avoid cases when emergency connection is not working on such reasons, which can not detect in advance.

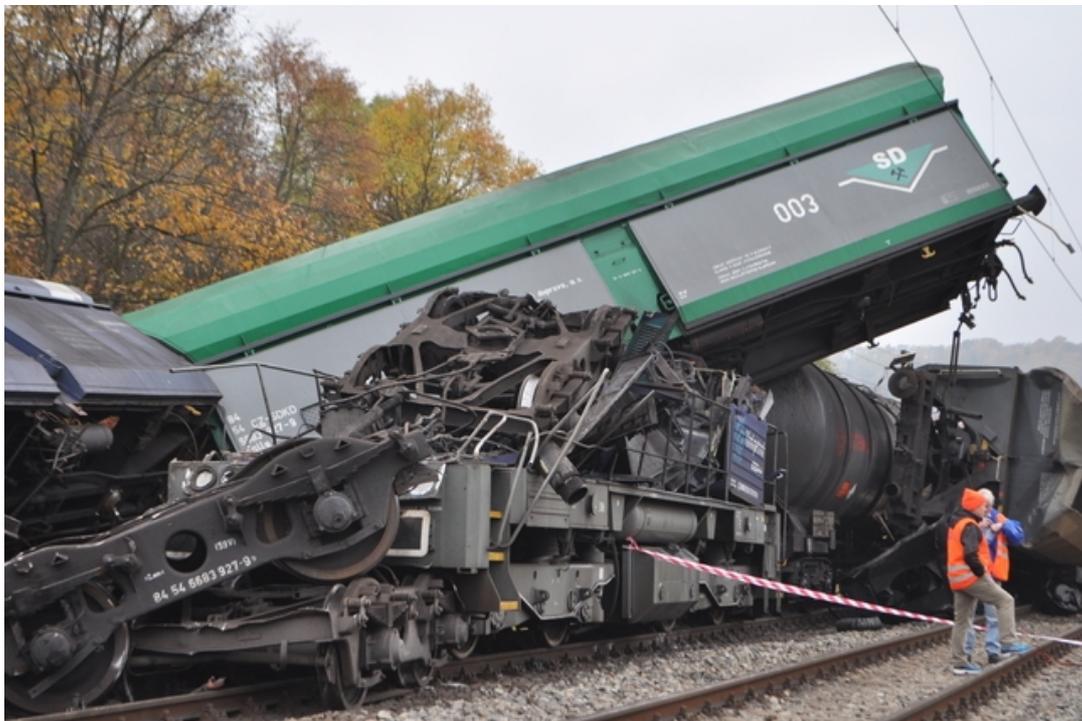
Grade:	serious accident.
Date and time:	3 rd November 2015, 19.01 (18.01 GMT).
Occurrence type:	trains collision with consequent derailment.
Description:	collision of shunting operation with another shunting operation standing on connection track No. 90 with consequent derailment of last two wagons.
Type of train:	2x shunting operation.
Location:	Česká Třebová station, junction track No. 90, km 0,865.
Parties:	SŽDC, s. o. (IM); ČD Cargo, a. s. (RU of the shunting operations).
Consequences:	1 injury; total damage CZK 7 680 500,-.
Direct cause:	<ul style="list-style-type: none">• failure to comply with condition for running on sight by train driver during the shunting operation.
Contributory factor:	<ul style="list-style-type: none">• failure to release of shunting route in front of the signal device Lc 403 with stop signal by the previous shunting operation.
Underlying cause:	<ul style="list-style-type: none">• failure to comply with technological procedures of the infrastructure manager and railway undertaking for shunting operation by the railway undertaking employees.

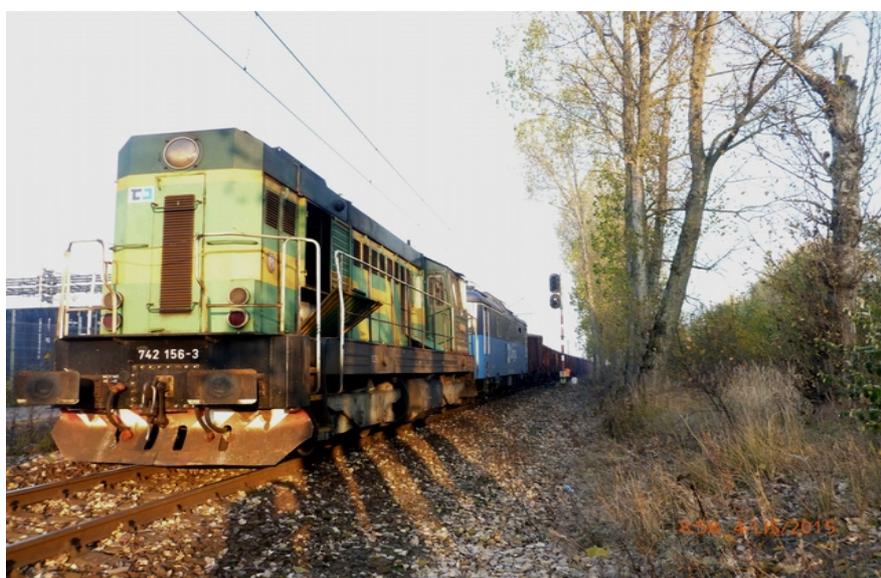
Grade:	a serious accident.
Date and time:	8 th November 2015, 21.53 (20.53 GMT).
Occurrence type:	a train derailment.
Description:	the derailment of the freight train No. 359511 due to a broken rail.
Type of train:	the freight train No. 359511.
Location:	Dřísy station, a station line No. 1, km 354,315.
Parties:	SŽDC, s. o. (IM); UNIPETROL DOPRAVA s. r. o. (RU of the freight train No. 359511).
Consequences:	0 fatality, 0 injury; total damage CZK 9 620 000,-
Direct cause:	the broken rail caused by rail defects.
Contributory factor:	<ul style="list-style-type: none">• poor technical condition of the rails, in which occurred many evolving rail defects;• occurrence of the deformation martensite on the surface of the running area.
Underlying cause:	<ul style="list-style-type: none">• violation of the technological processes of the infrastructure manager – failure to adopt appropriate measures due to the condition of the visible defects on the head of the two stretch of rails at km 353.809 – 354.476;• insufficient or ineffective control activities of the infrastructure manager which resulted in insufficient removal of source of danger to the rail system.

The purpose of the above safety recommendations is to achieve responsible approach of employees of the infrastructure manager at all levels of management to ensuring the technical conditions of the rail system, especially considering the defects of rail components and their timely removal, for which must be established a control system.

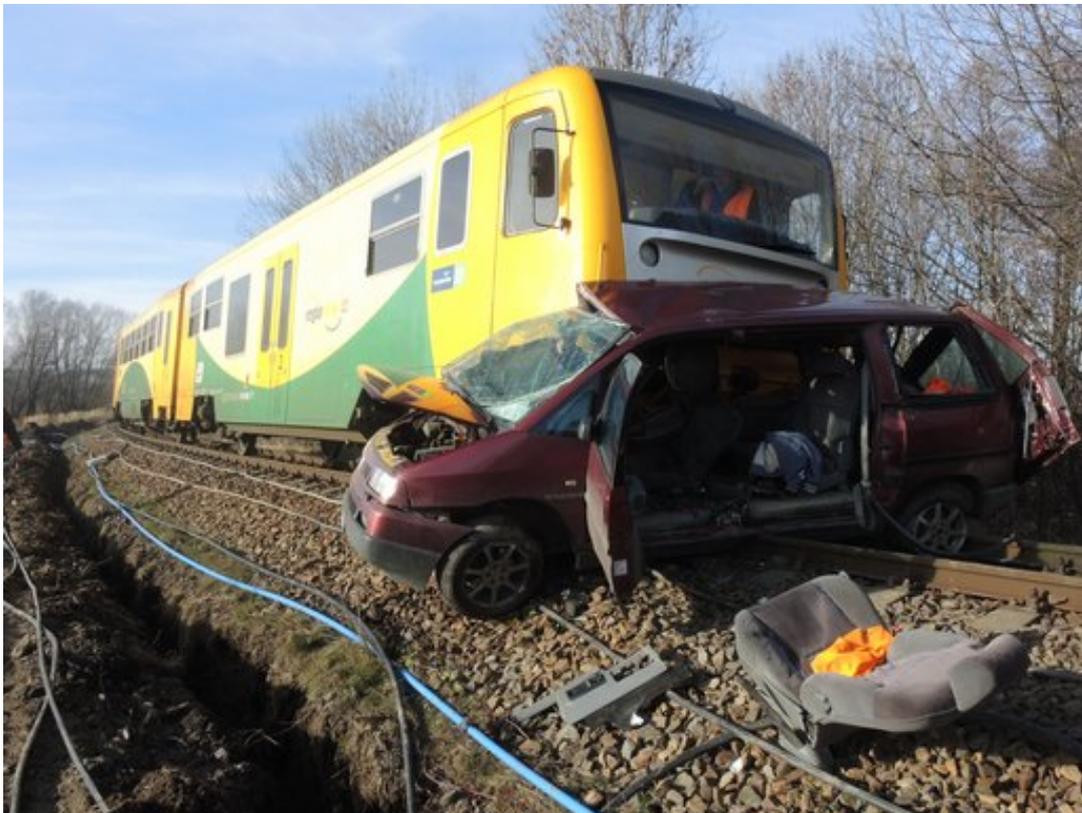
Grade:	accident.
Date and time:	11 th December 2015, 7.38 (6.38 GMT).
Occurrence type:	level crossing accident.
Description:	collision of regional passenger train No. 3125 with a truck at level crossing No. P7408.
Type of train:	regional passenger train No. 3125.
Location:	Frýdek-Místek station, level crossing No. 7408, km 21,580.
Parties:	SŽDC, s. o. (IM); ČD, a. s. (RU of the regional passenger train); driver of the truck (level crossing user).
Consequences:	0 fatalities, 0 injuries; total damage CZK 868 436,-
Direct cause:	<ul style="list-style-type: none">• third party – level crossing user (truck driver violation). Entry onto the level crossing No. P7408 when acoustic and visual warnings were being given, at the time when the train No. 3125 was approaching the level crossing.
Contributory factor:	none.
Underlying cause:	<ul style="list-style-type: none">• insufficient attention during driving the truck, that caused oversight of traffic signs before the level crossing and failure to register acoustic and visual warnings of the level crossing safety equipment system.

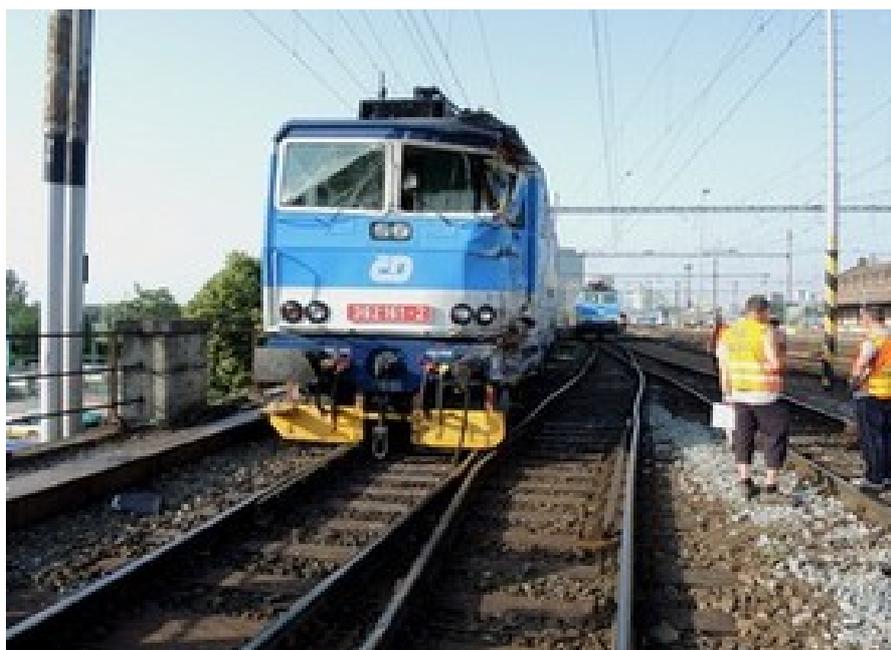
Grade:	a serious accident.
Date and time:	10 th July 2016, 6.58 (4.58 GMT).
Occurrence type:	a trains collision.
Description:	an unauthorized movement of the regional passenger train No. 17016 behind a signal "Stop point" with a consequent collision with the regional passenger train No. 17007.
Type of train:	the regional passenger train No. 17016; the regional passenger train No. 17007.
Location:	Rotava operating control point, a place of the unauthorized movement (km 17,829), a place of the trains collision (km 18,095).
Parties:	PDV RAILWAY a. s. (IM); GW Train Regio a. s. (RU of regional passenger trains).
Consequences:	5 injuries (3 passengers, a conductor and a train driver of the train No.17016); total damage CZK 3 109 340,-
Direct cause:	a failure to wait of an arrival of the regional passenger train No. 17007 from Rotava operating point without a permission from a dispatcher.
Contributory factor:	none.

- it is recommended to take own measure forcing implementation of the above recommendations for other all IMs and RUs in the Czech republic and to implement recommendation No. 6-294/2011/DI from 5th September 2011.
