The Rail Safety
Inspection Office

NIB ANNUAL REPORT 2018

according to Article 23(3) of Directive 2004/49/EC

September 2019

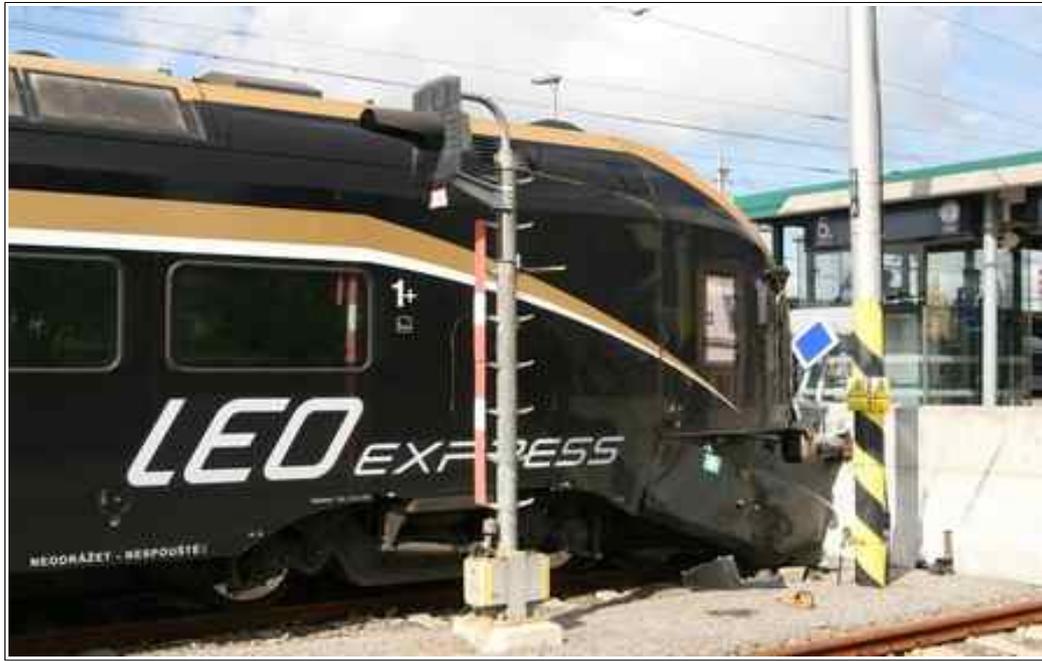
Grade:	an incident.
Date and time:	10 th June 2017, 9:12:49 (7:12:49 GMT).
Occurrence type:	an uncontrolled ride.
Description:	the uncontrolled movement of the shunting operation from the excluded track to the operated station track and its entry into the train route of the regional passenger train No. 9320 at Český Brod station.
Type of train:	the shunting operation; the regional passenger train No. 9320.
Location:	Český Brod station, the switch No. 45, km 377,795.
Parties:	SŽDC, s. o. (IM and RU of the shunting operation); ČD, a. s. (RU of the regional passenger train No. 9320); MONZAS, s. r. o. (different legal person working on the switch No. 45); STRABAG Rail, a. s. (different legal person working on the switch No. 45);
Consequences:	0 fatalities, 0 injuries; total damage CZK 0,-
Direct cause:	<ul style="list-style-type: none">• an unintended movement of the shunting operation through the switch No. 45 switched into the wrong direction.

Root cause: none.

Recommendations: not issued.

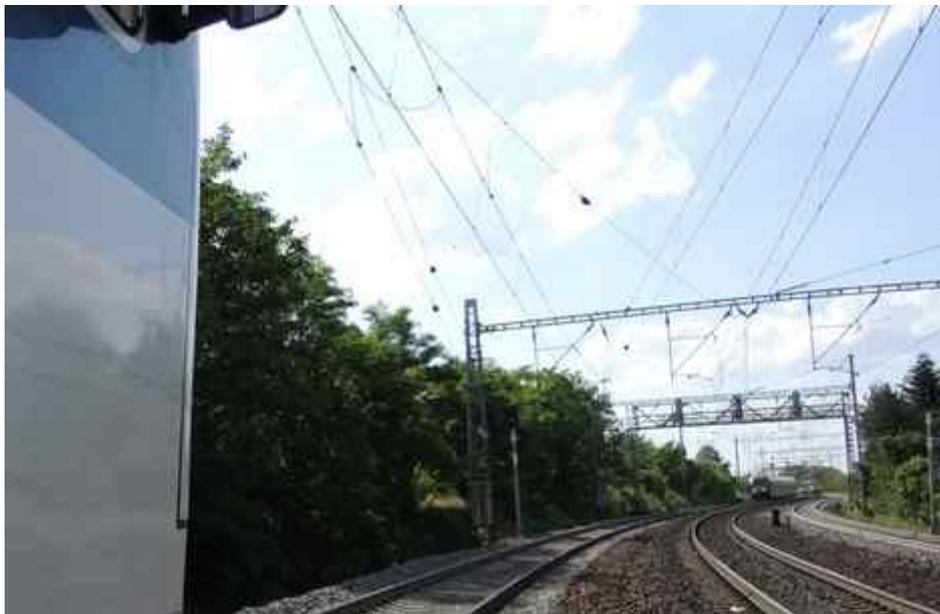
- Grade: accident.
- Date and time: 8th July 2017, 20:53 and 20:58 (18:53 and 18:58 GMT).
- Occurrence type: collision of the train with an obstacle.
- Description: collisions of the freight trains No. 69101 and No. 52297 with stones, which flew from the freight train No. 60202, which went in opposite way.

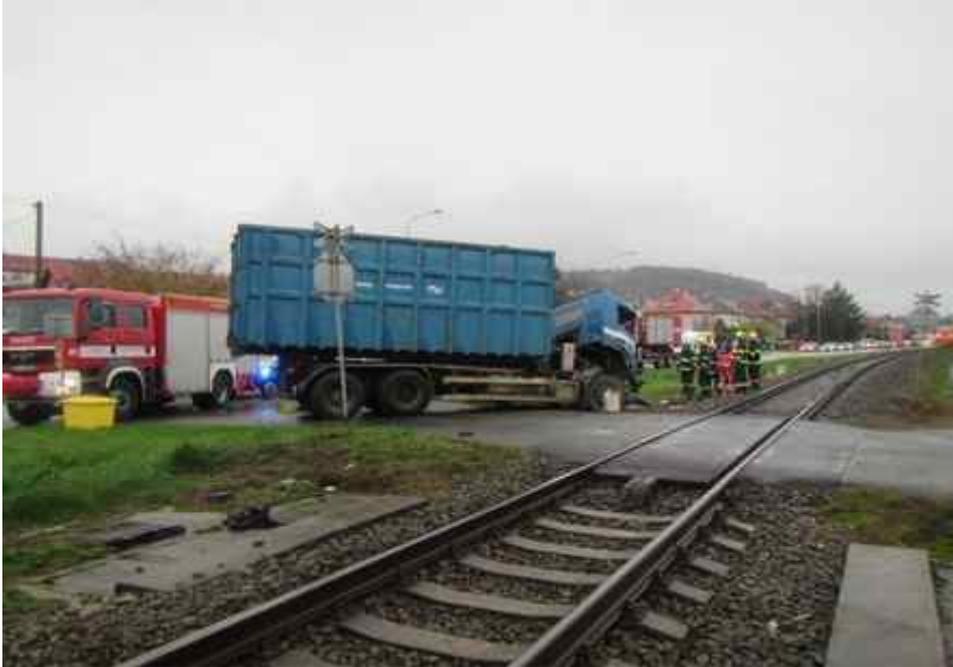
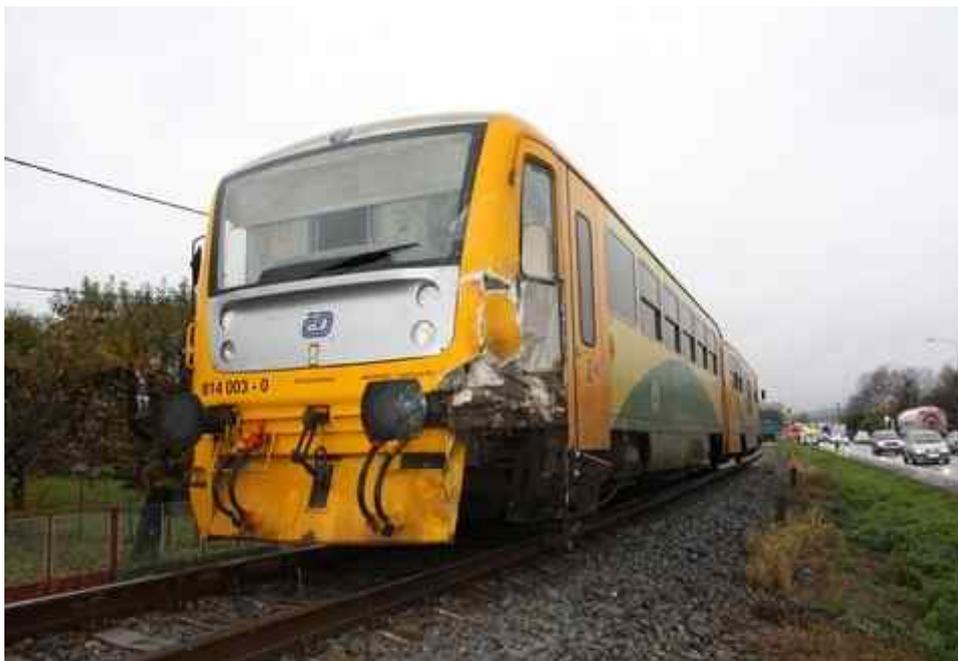
- Grade: accident.
- Date and time: 22nd November 2017, 4:43 (3:43 GMT).
- Occurrence type: level crossing accident.
- Description: collision of the regional passenger train No. 18420 with the car with consequent derailment at the level crossing No. P6382.

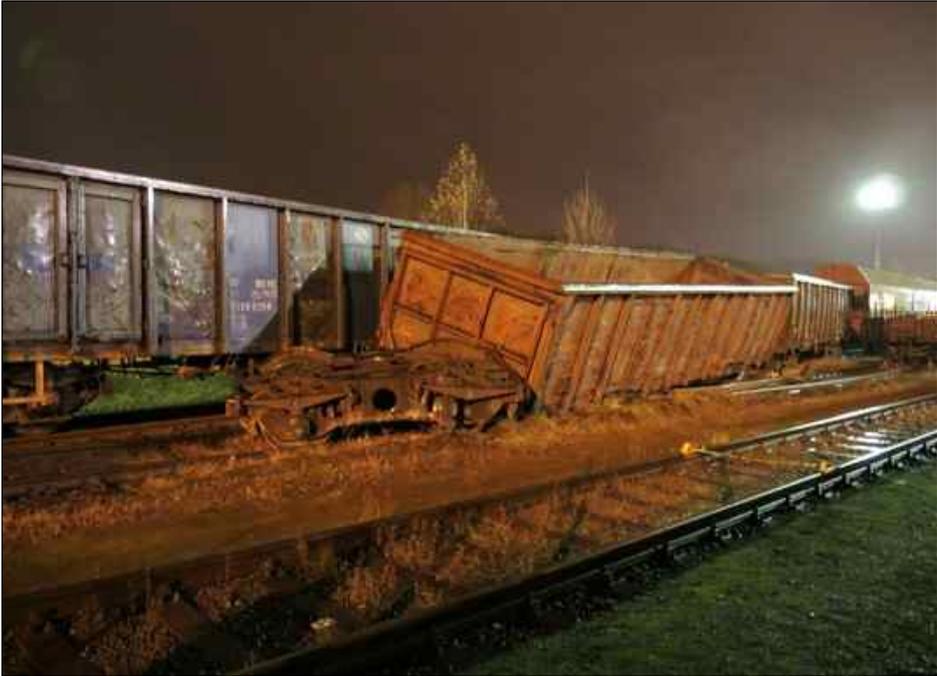
Grade:	serious accident.
Date and time:	1 st December 2017, 20:25 (19:25 GMT).
Occurrence type:	train derailment.
Description:	derailment of one rolling stock of the freight train No. 67260 with consequent disruption of the train into 3 parts.
Type of train:	freight train No. 67260.
Location:	open line between Libčice nad Vltavou and Kralupy nad Vltavou stations, track line No. 2, km 433,294.
Parties:	SŽDC, s. o. (IM); ČD Cargo, a. s. (RU of the freight train No. 67260).
Consequences:	0 fatality, 0 injury; total damage CZK 16 734 700,-
Direct cause:	<ul style="list-style-type: none">fatigue fracture of the axle No. 018895579 of the freight wagon No. 31 51 5318 167-4 with consequent fall down of an axelbox.
Contributory factor:	none.
Underlying cause:	<ul style="list-style-type: none">weakening cross section of axel's pivot due to expansion of old fracture, which could not be detected by the maintenance.

Root cause:	none.
Recommendation:	not issued.

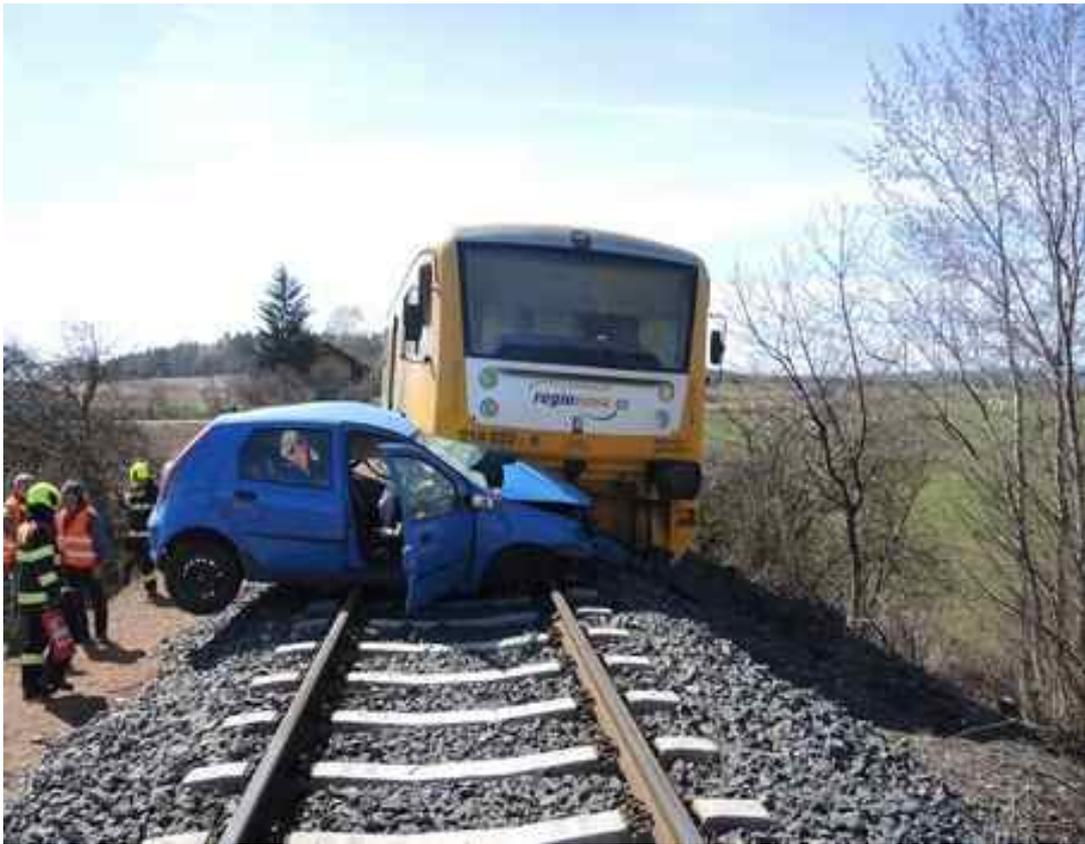
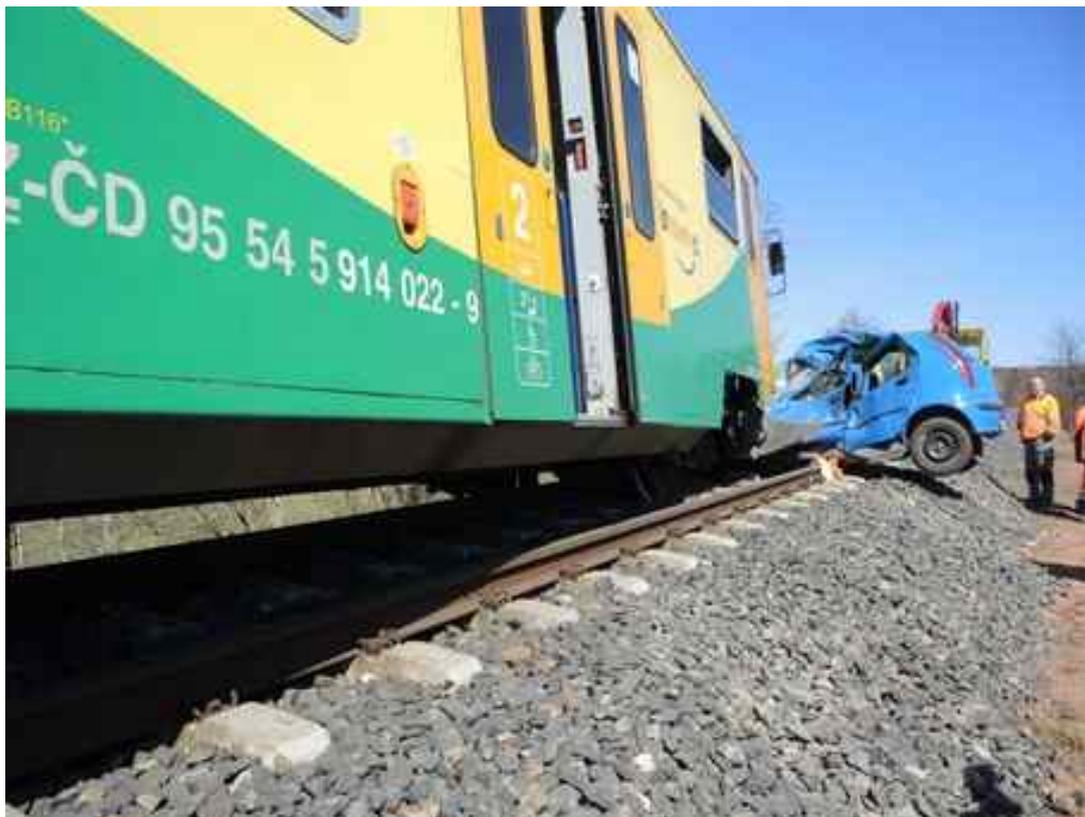
- Grade: an accident.
- Date and time: 17th April 2018, 12:33 (10:33 GMT).
- Occurrence type: a level crossing accident.
- Description: the collision of the long distance passenger train No. 1246 with the car at the level crossing.

- Direct cause:
- driver's failure to respect the light and acoustic warning and driving across the level crossing at the time when it was forbidden and visual and acoustic warnings were being given.

- Contributory factor: none.
- Underlying causes:
- driver's failure to respect the light and acoustic warning and his ride at the level crossing at the time when it was forbidden;

- behavior of the driver in front of the level crossing, the car driver wasn't careful enough.
- Root cause: none.
- Recommendation:
- Addressed to The Czech National Safety Authority (NSA):

- it is recommended to adopt own measure for implementation of the previously issued safety recommendations, so that only level crossing system with warning lights and barriers will be designed, installed and approved at the level crossings at time of reconstruction and modernization of railway tracks and level crossings;

- due to repetition of similar accidents with tragic consequences at the level crossing No. P558 which is equipped with warning lights (there were 3 similar accidents with the death of car drivers from 30th July 2017 to 17th April 2018) it is recommended to adopt own measure to change the level crossing system of the level crossing No. P558 which should be added with barriers as an optical barrier which is able to reduce the probability of a driver's entrance at the level crossing when the driver does not respond to the light and acoustic warning of the crossing system.

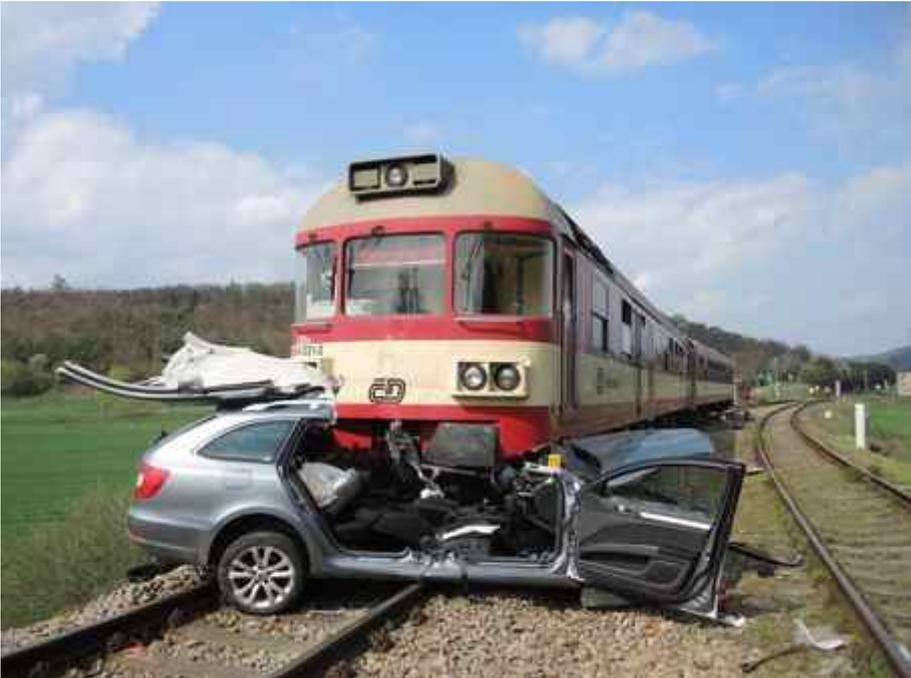
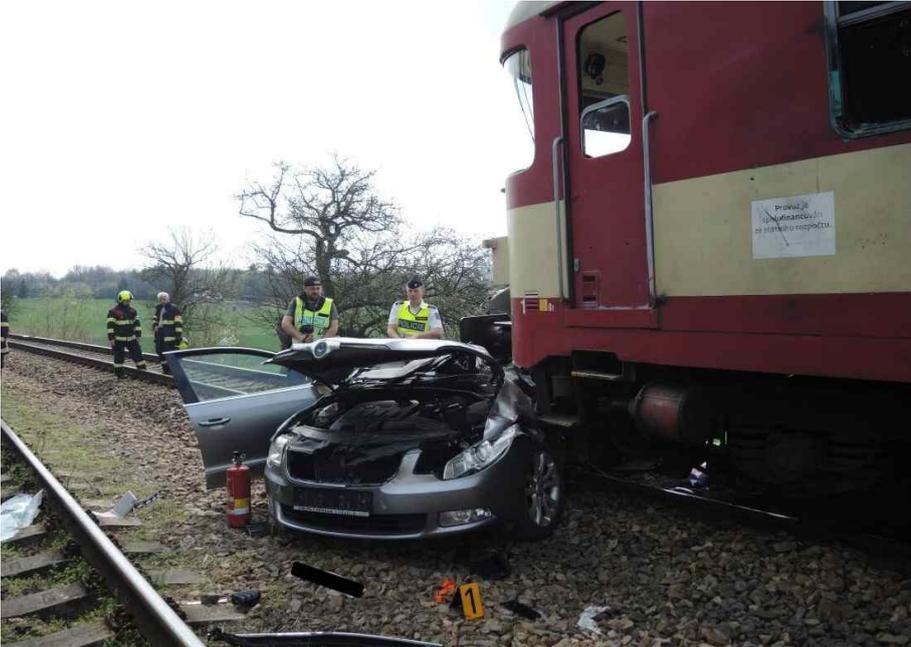
Grade:	accident.
Date and time:	23 rd April 2018, 13:29 (11:29 GMT).
Occurrence type:	level crossing accident.
Description:	collision of the regional passenger train No. 7908 with a car at the level crossing with consequent derailment.
Type of train:	regional passenger train No. 7908.
Location:	open line between Lochovice and Jince stations, level crossing No. P552, km 87,595.
Parties:	SŽDC, s. o. (IM); ČD, a. s. (RU of the regional passenger train No. 7908); driver of the car (level crossing user).
Consequences:	1 serious injury; total damage CZK 814 200,-
Direct cause:	<ul style="list-style-type: none">standing of the car at the dangerous area of the level crossing at the time of the train movement.
Contributory factor:	none.
Underlying cause:	<ul style="list-style-type: none">the impossibility to leave the dangerous area of the level crossing by the car due to deadlock of left front wheel between stretch of rails outside of level crossing roadway.

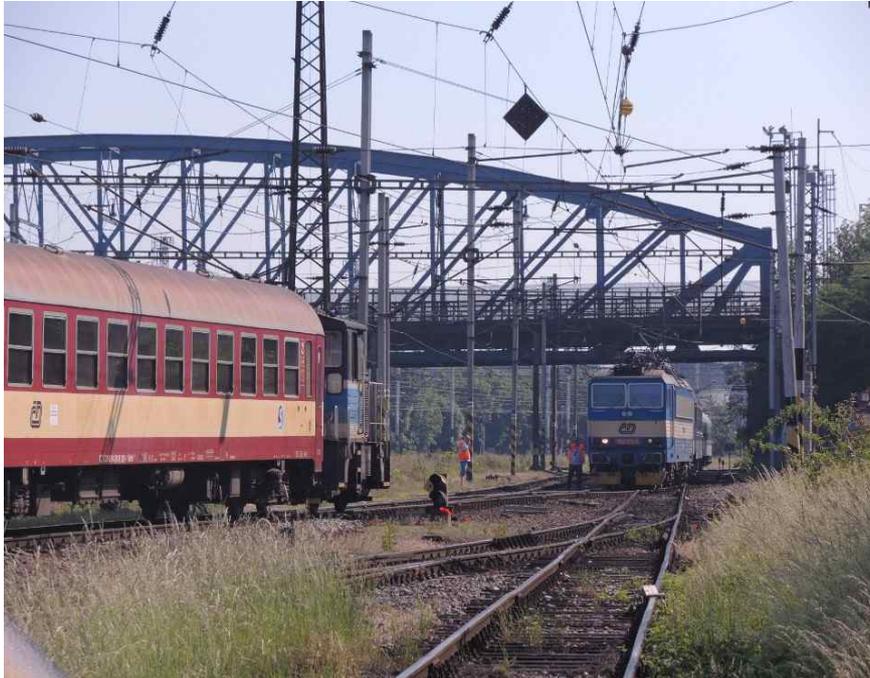
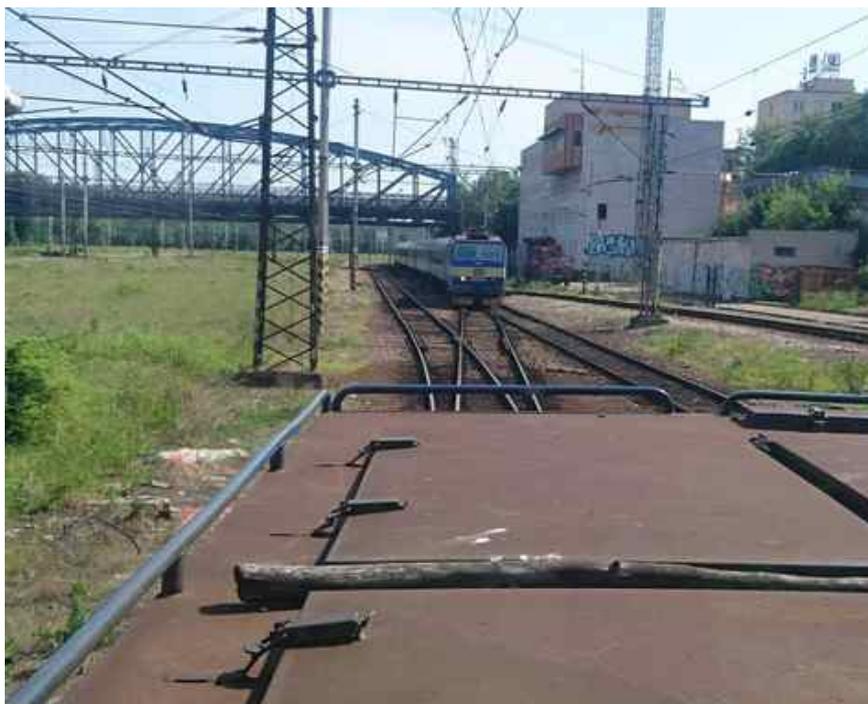
Grade:	an incident.
Date and time:	28 th May 2018, 5:06 (3:06 GMT).
Occurrence type:	an unauthorized movement.
Description:	the unauthorized movement of the freight train No. 43333 behind the main (route) signal device Sc1 with the consequent movement into the train route of the regional passenger train No. 6905.
Type of train:	a freight train No. 43333; a regional passenger train No. 6905.
Location:	Ústí nad Labem hlavní nádraží station, the station track No. 1, the signal device Sc1, km 516,752.
Parties:	SŽDC, s. o. (IM); ČD, a. s. (RU of the regional passenger train No. 6905); METRANS Rail, s. r. o. (RU of the freight train No. 43333).
Consequences:	0 fatality, 0 injury; total damage CZK 0,-
Direct cause:	<ul style="list-style-type: none">the train driver's of the freight train No. 43333 operational error (he did not respect the signal „Stop” of the main route signal Sc1 at Ústí nad Labem hlavní nádraží station).

Contributory factor:	<ul style="list-style-type: none">an absence of the technical equipment which prevents a train from passing a signal in case of danger.
Underlying cause:	<ul style="list-style-type: none">a mistake of the train driver of the freight train No. 43333 who mistook the signal at the main (route) signal device Sc3 which was not for the track line No. 1 for the signal at the main (route) signal device Sc1.
Root cause:	none.
Recommendation:	not issued.

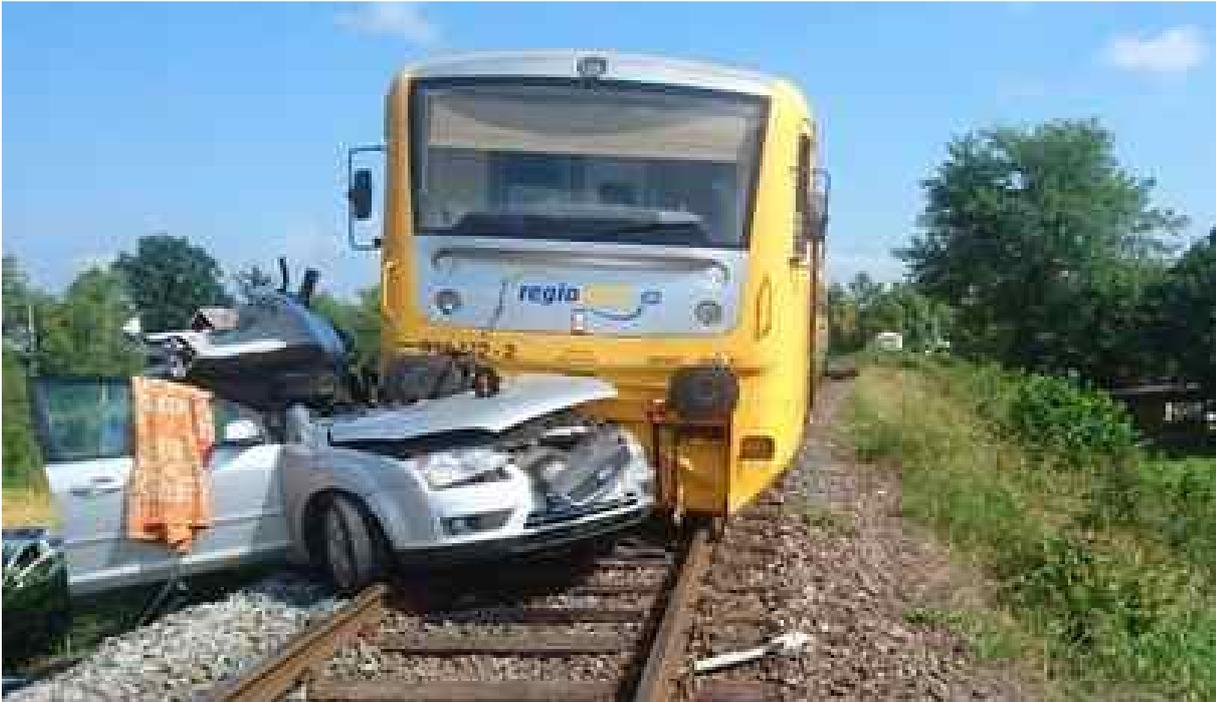
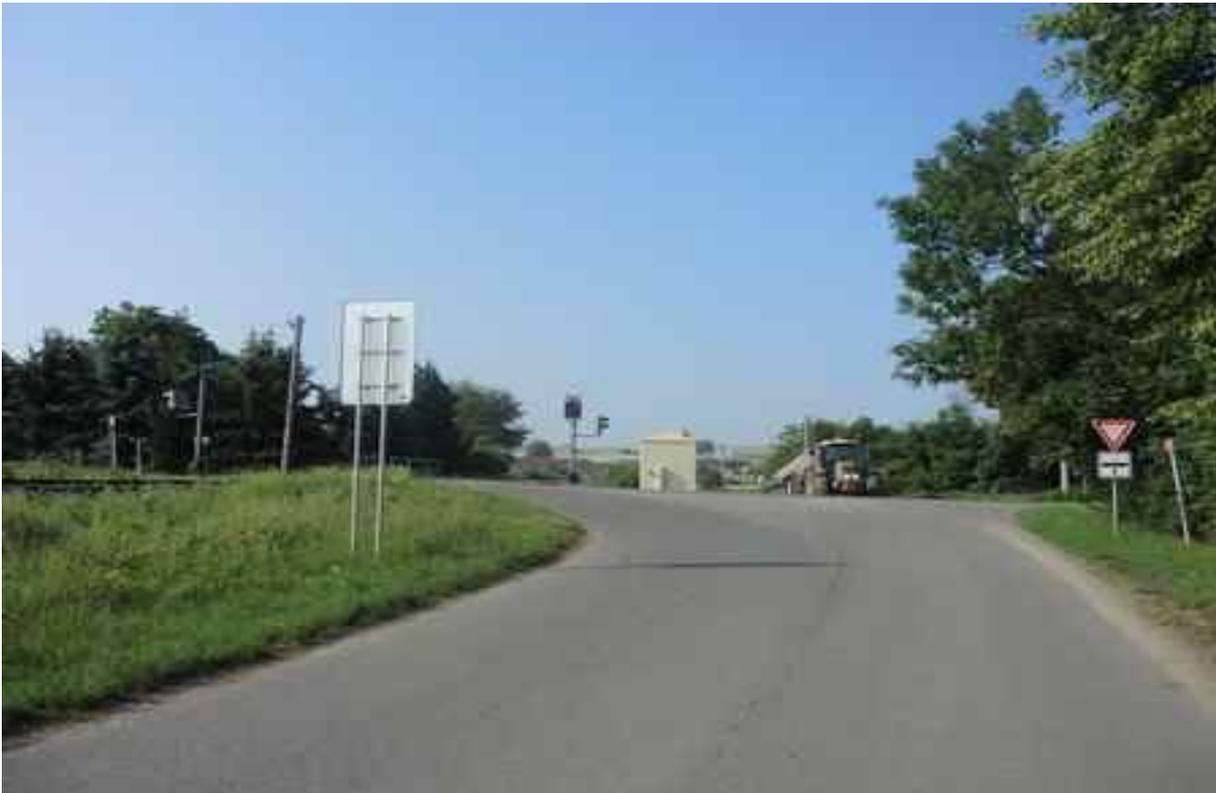
Grade:	accident.
Date and time:	11 th July 2018, 17:51 (15:51 GMT).
Occurrence type:	level crossing accident.
Description:	collision of the long distance passenger No. 352 with a car at the level crossing.
Type of train:	the long distance passenger train No. 352.
Location:	Staňkov station, the level crossing No. P619, km 148,280.
Parties:	SŽDC, s. o. (IM); ČD, a. s. (RU of the long distance passenger train No. 352); a car driver (level crossing user).
Consequences:	1 fatality and 3 injuries; total damage CZK 452 948,-
Direct cause:	<ul style="list-style-type: none">• driver's failure to respect the light and acoustic warning and driving across the level crossing at the time when it was forbidden and visual and acoustic warnings were being given.
Contributory factor:	none.
Underlying causes:	<ul style="list-style-type: none">• driver's failure to respect the light and acoustic warning of the level crossing safety equipment;• driver's behavior in front of the level crossing, the driver was not careful enough.
