The Rail Safety
Inspection Office

NIB ANNUAL REPORT 2017

according to Article 23(3) of Directive 2004/49/EC

September 2018

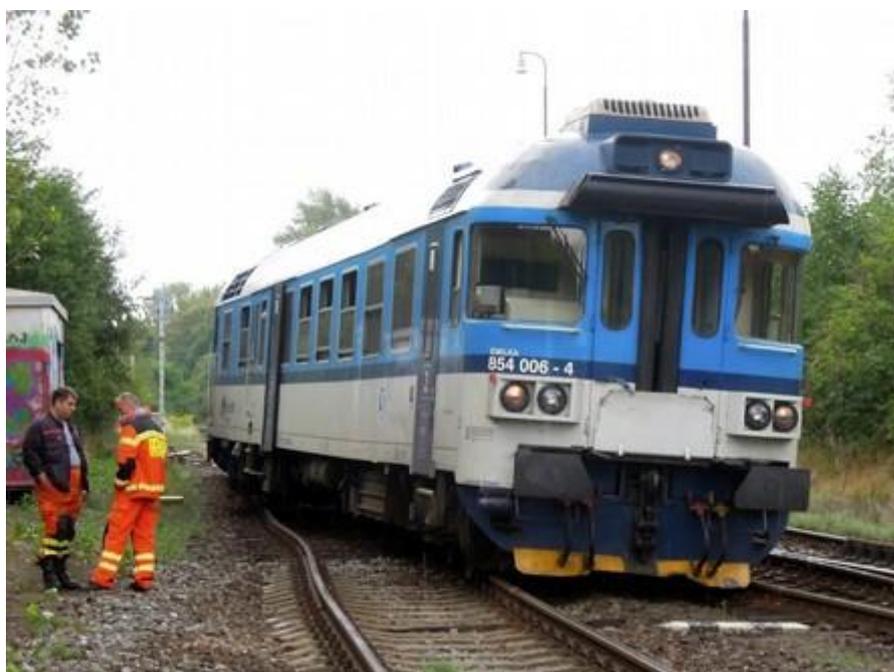
Grade:	incident.
Date and time:	16 th August 2017, 7:04 (5:04 GMT).
Occurrence type:	train derailment.
Description:	derailment of the regional passenger train No. 9522 due to switching of the switch No. 1 closely in front of the moving train.
Type of train:	regional passenger train No. 9522.
Location:	Praha-Čakovice station, switch No. 1, km 18,563.
Parties:	SŽDC, s. o. (IM); ČD, a. s. (RU of the regional passenger train No. 9522).
Consequences:	0 fatality, 0 injury; total damage CZK 258 629,-
Direct cause:	<ul style="list-style-type: none">• unauthorized switching of the switch No. 1 closely in front of the moving regional passenger train No. 9522.
Contributory factor:	none.
Underlying cause:	<ul style="list-style-type: none">• failure to observe the technological procedures of the IM during manipulation with the switch No. 1.
Root cause:	none.
Recommendation:	not issued.
