**The Rail Safety
Inspection Office**

NIB ANNUAL REPORT 2020

The Rail Safety Inspection Office

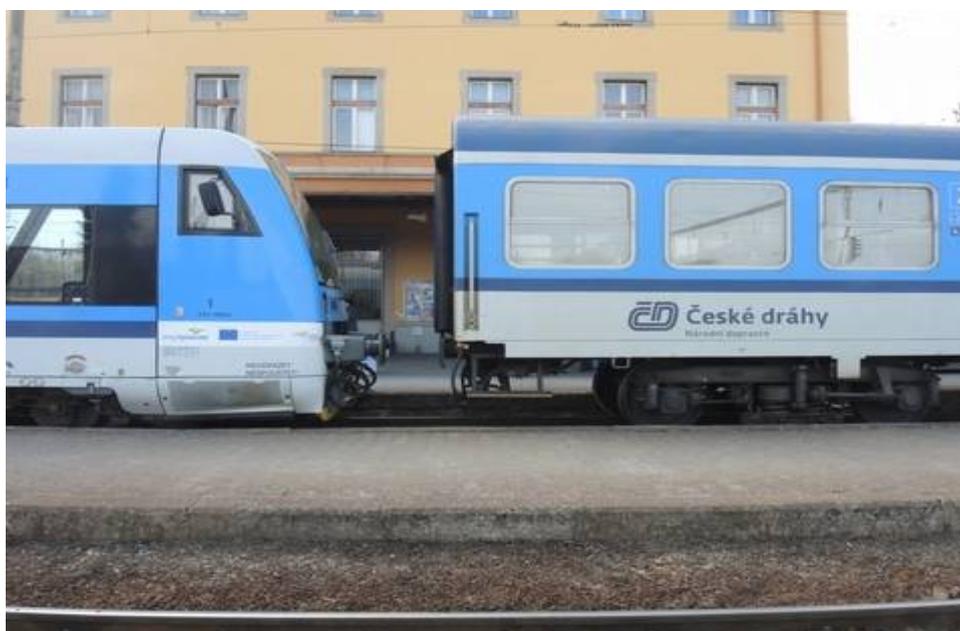
- Grade: a serious accident.
- Date and time: 4th March 2019, 12:19 (10:19 GMT).
- Occurrence type: a train collision.
- Description: an unauthorized departure of the regional passenger train No. 15912 from Ronov nad Doubravou operating control point and its consequent collision with the freight train No. 84261.

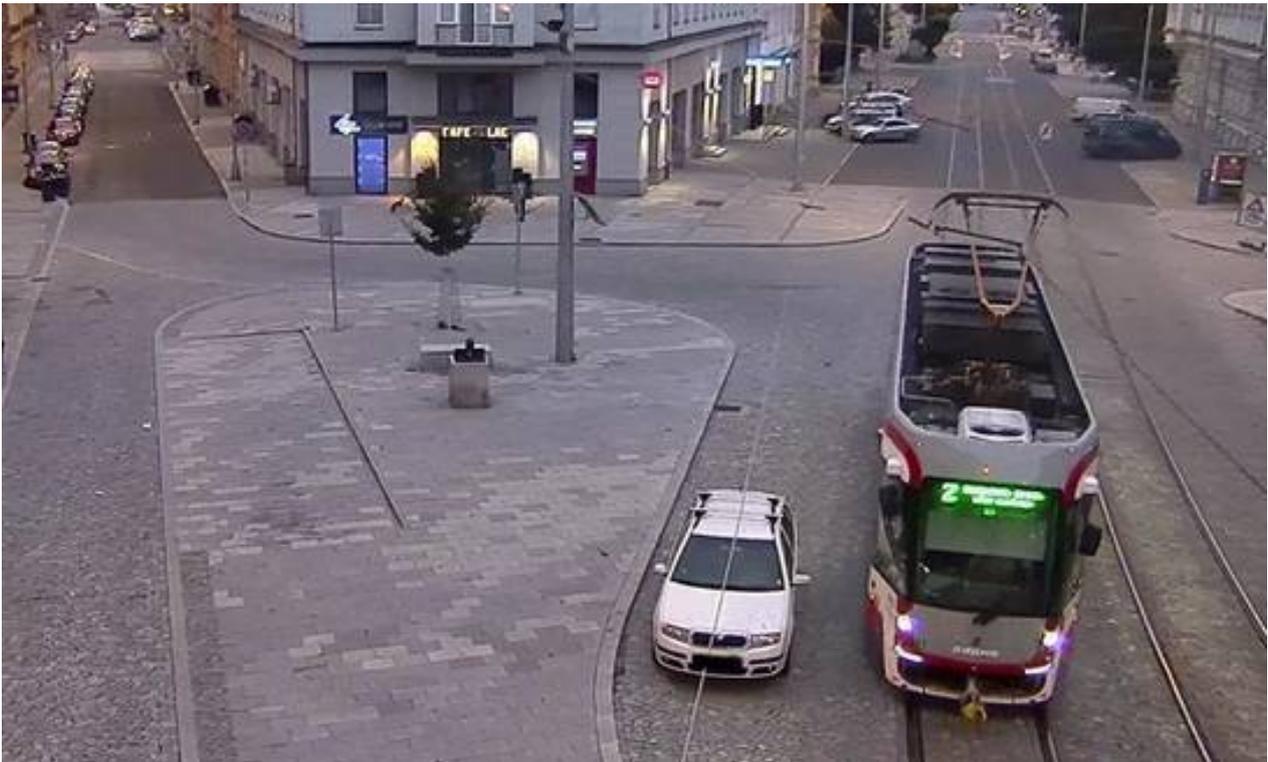
Contributory factor:	none.
Underlying cause:	<ul style="list-style-type: none">inattention of the supervisor of the shunting operation (who was at the head of the shunting operation), who did not instruct the train driver of the shunting operation to stop in time, so that the shunting operation was not able to stop safely at latest at the end of the shunting operation route, ie. in front of the shunting signal device Se81.
Root cause:	none.
Recommendation:	not issued.

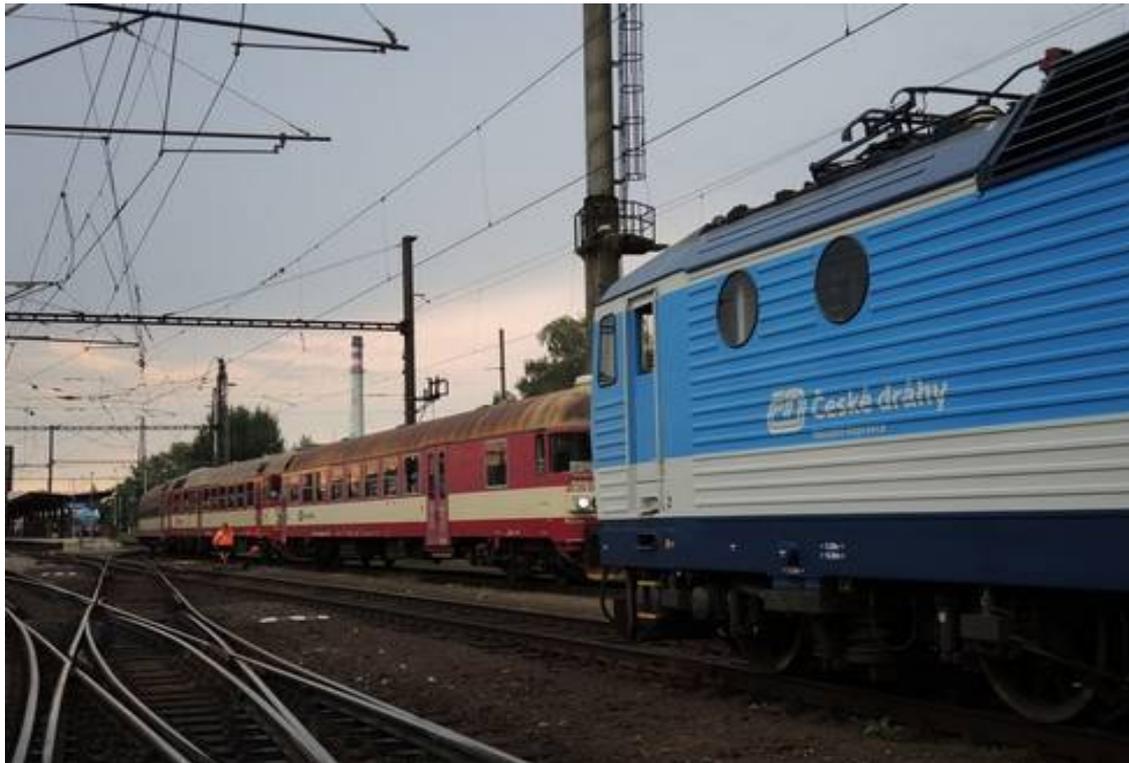
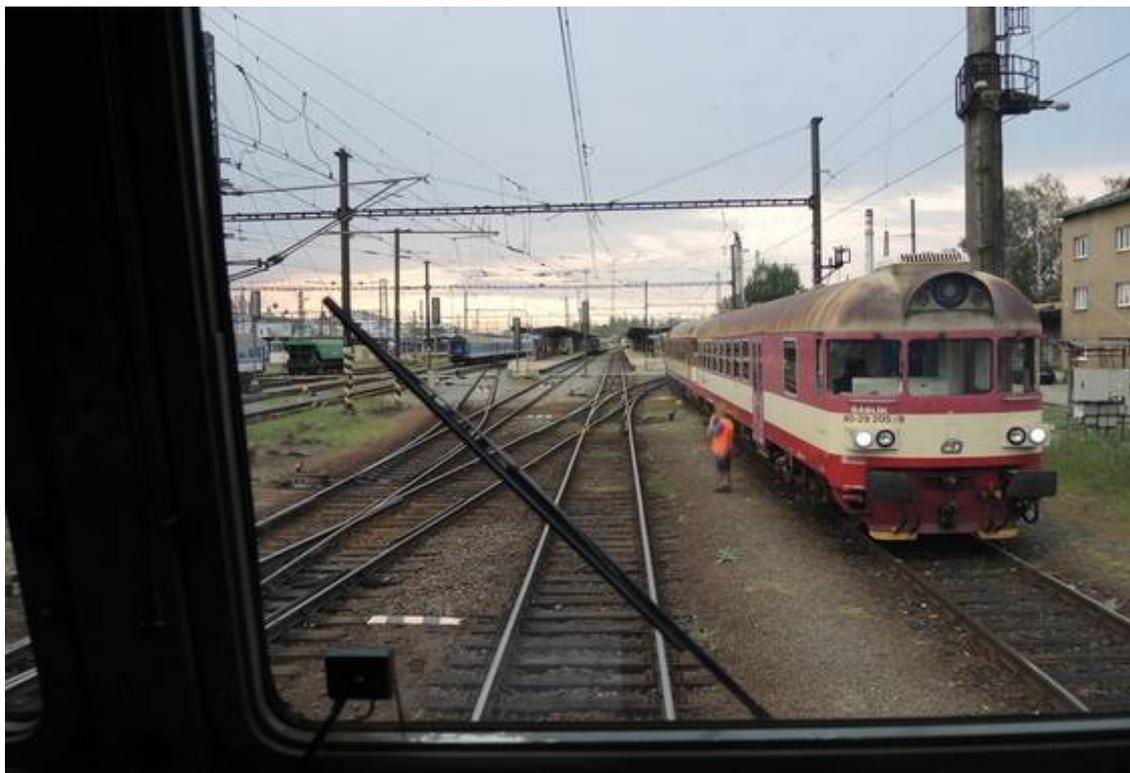
Grade:	incident.
Date and time:	31 st August 2019, 15:34 (13:34 GMT).
Occurrence type:	unsecured movement.
Description:	unsecured movement of the regional passenger train No. 14226 with consequent derailment.
Type of train:	the regional passenger train No. 14226.
Location:	Lípa nad Dřevnicí station, switch No. 1sv, km 18,931.
Parties:	SŽDC, s. o. (IM); ČD, a. s. (RU of the regional passenger train No. 14226).
Consequences:	0 fatality, 0 injury; total damage CZK 791 897,-
Direct cause:	<ul style="list-style-type: none">• permission for the train movement over the switch in resetting mode which was not switched to the end position for the priority direction of the train movement.
Contributory factor:	none.
Underlying cause:	<ul style="list-style-type: none">• failure to comply of the technological procedures of the IM for ensure of safety while driving the train in time of disorder of normal position of self-returning switch.

Root cause:	none.
Recommendation:	not issued.

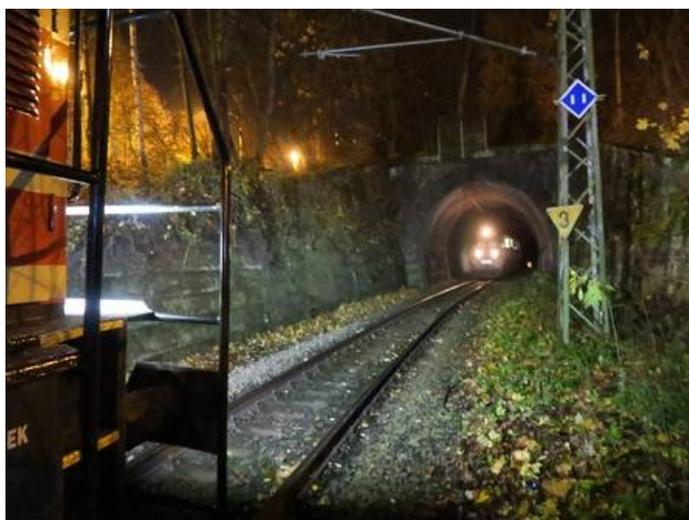
Grade:	an incident.
Date and time:	18 th November 2019, 19:20 (18:20 GMT).
Occurrence type:	an unauthorized movement.
Description:	the unauthorized movement of the shunting operation behind the signal device „Limit of shunting indicator“ and its consequent ride into open line section occupied by the locomotive train No. 57478.
Type of train:	the locomotive train No. 57478; the shunting operation.
Location:	Děčín východ dolní nádraží station, km 457,771.
Parties:	SŽDC, s. o. (IM); IDS CARGO a. s. (RU of the shunting operation and the locomotive train No. 57478).
Consequences:	0 fatality, 0 injury; total damage CZK 0,-
Direct cause:	<ul style="list-style-type: none">• failure to respect the instruction of the IM – the signal „shunting forbidden“ given by the signal device „Limit of shunting indicator“.
Contributory factor:	<ul style="list-style-type: none">• the unauthorized movement of the shunting operation when the permission to shunt was not given.• the issued order to make a train route without previous permission to shunt.

Underlying cause:	<ul style="list-style-type: none">• failure to ensure the technological procedures of the IM – the movement of the shunting operation behind the signal device „Limit of shunting indicator“ without the permission of the station dispatcher.
Root cause:	none.
Recommendation:	not issued.

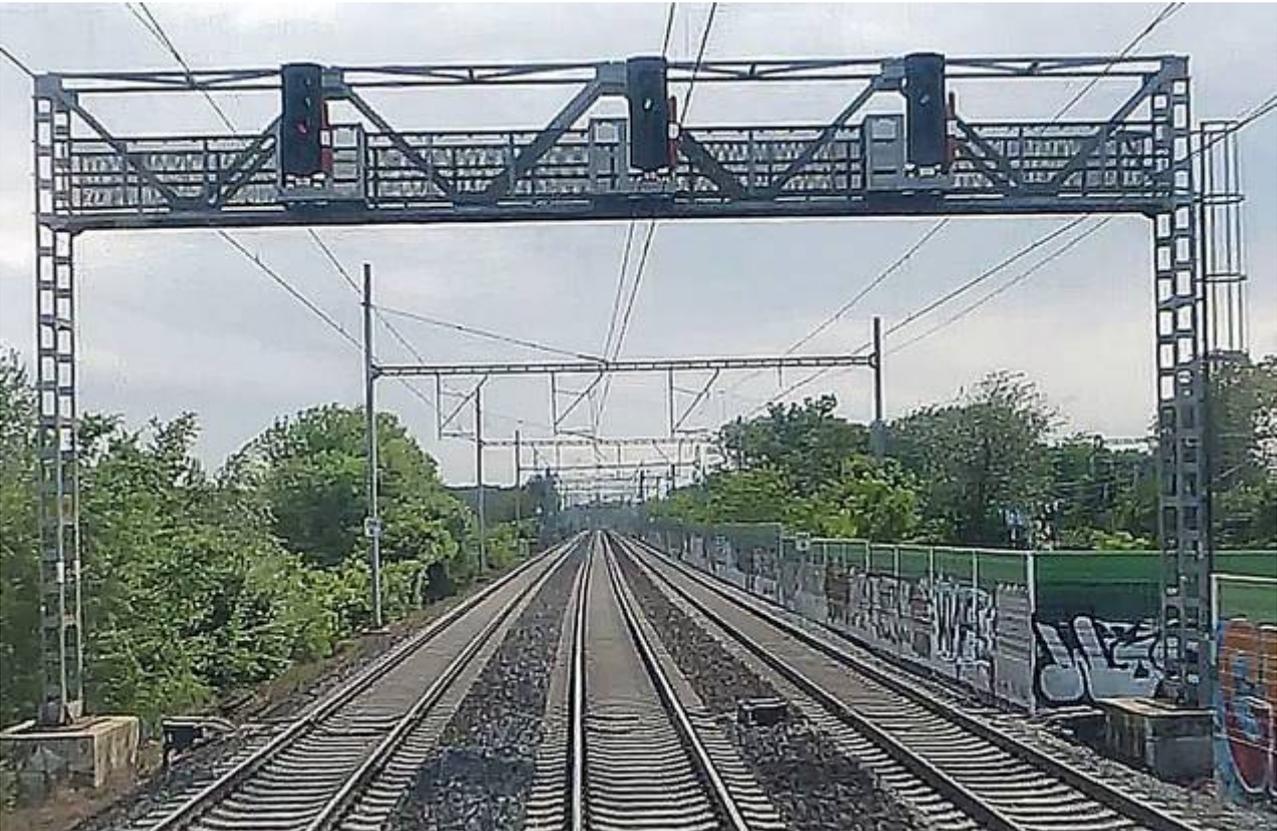
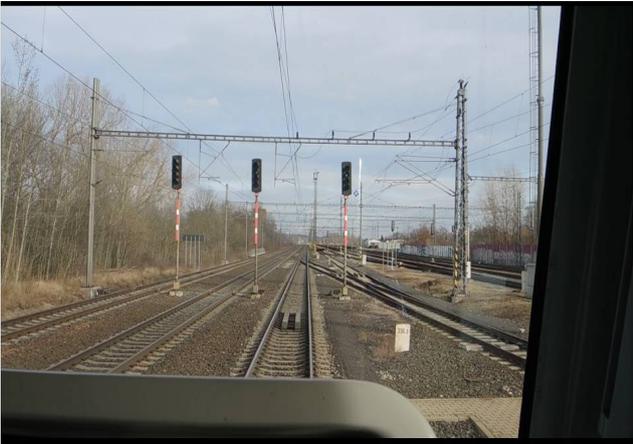
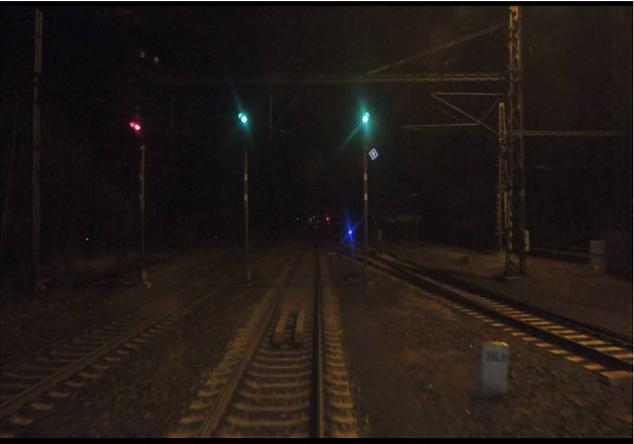
- Consequences: 0 fatality, 0 injury;
total damage CZK 310 855,-
- Direct cause:
- failure to respect the signal „Stop” of the main (departure) signal device S0a at Praha-Běchovice station by the train driver of the freight train No. 57506.

- Contributory factor:
- absence of technical equipment which prevents a train from passing a signal in case of danger.
- Underlying causes:
- unintentional mistake of the train driver of the train Pn 57506, when observing the signals of the main signal devices at Praha-Běchovice station, the train driver of the train Pn 57506 erroneously interchanged the main (departure) signal S1a, which signaled „Speed 100 kph and green signal”, for the main (departure) signal device S0a, which signaled the signal „Stop”, in the dark;

- Root cause: none.
- Recommendation:
- Addressed to the Czech Ministry of Transport (hereinafter „the Ministry”) in cooperation with The Czech National Safety Authority (the NSA):

- we recommend the Ministry in cooperation with the NSA initiate an amendment and supplementing to content of the count 1.7 of the Annex 3 to the Decree No. 16/2012 Coll., so that information on relevant accidents and incidents that have occurred on the defined railway track or its part (it is important not to relate this information to only one RU, but to all accidents and incidents on the specific railway track) will be amended.

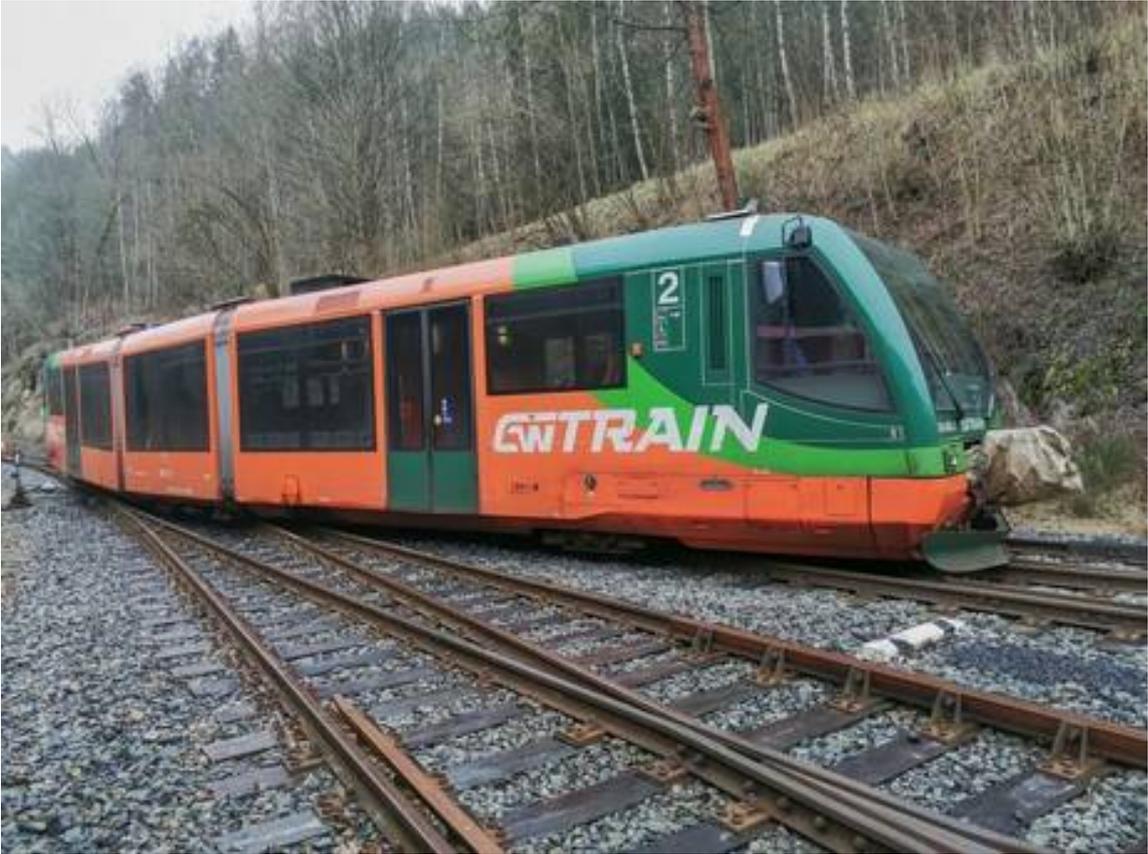
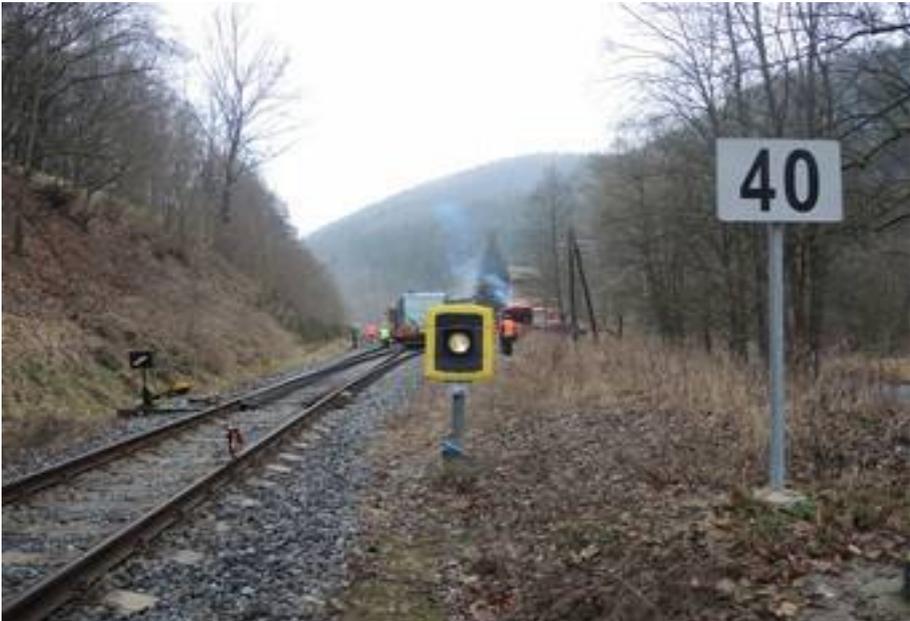
Grade:	incident.
Date and time:	17 th January 2020, 5:47 (4:47 GMT).
Occurrence type:	train derailment.
Description:	derailment of the regional passenger train No. 7122.
Type of train:	the regional passenger train No. 7122.
Location:	Krásný Jez operational control point, switch No. 1sv, km 37,485.
Parties:	Správa železnic, státní organizace (IM); GW Train Regio a.s. (RU of the regional passenger train No. 7122).
Consequences:	0 fatality, 0 injury; total damage CZK 838 915,-
Direct cause:	<ul style="list-style-type: none">the train driver did not obey the instruction of the signal device Sv1 before entering on the switch No. 1sv at Krásný Jez operational control point.
Contributory factor:	none.
Underlying cause:	<ul style="list-style-type: none">failure to comply of the technological procedures of IM, due to failure to observe of signal device Sv1 and failure to act according to the findings (failure to stop the regional passenger train No. 7122 in front of the switch No. 1sv and also failure to control its correct position).

Root cause:	none.
Recommendation:	
Addressed to The Czech National Safety Authority (NSA):	<ul style="list-style-type: none">following the previously issued safety recommendation reference number 720/2016/DI, of 9th November 2016, to adopt in cooperation with the IMs of the regional railways its own measures to ensure adjustment of the electronic control and diagnostic system REMOTE 98 so that the loss of the preferred position of the switch with the resetting point operating mechanism is indicated not only optically on the screen of the monitor of the uniform operating workplace, but also by displaying the window of fault messages with their listing, and further acoustically.

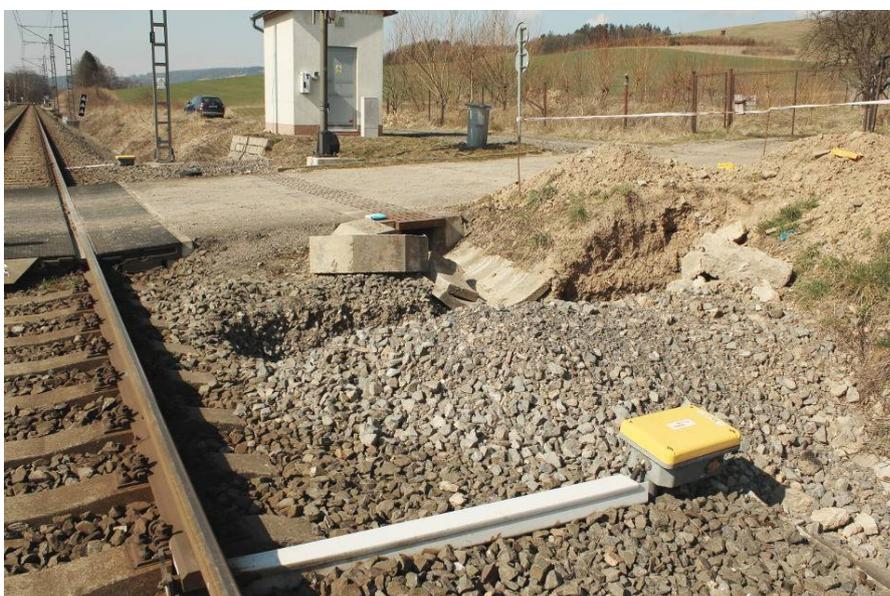
Grade:	accident.
Date and time:	18 th February 2020, 10:52 (9:52 GMT).
Occurrence type:	accident to person caused by rolling stock in motion.
Description:	collision of the freight train No. 44251 with the external worker in the operated railway infrastructure.
Type of train:	the freight train No. 44251.
Location:	open line between Lichkov station and Lichkov state border, km 112,379.
Parties:	Správa železnic, státní organizace (IM); ČD Cargo, a. s. (RU of the freight train No. 44251); the external worker.
Consequences:	1 fatality; total damage CZK 0,-
Direct cause:	<ul style="list-style-type: none">• entry of the external worker into the structure gauge of operated open line track while the freight train No. 44251 was moving around the workplace.
Contributory factor:	<ul style="list-style-type: none">• behavior of the external worker affected by an addictive substance at the time of the work shift during which accident occurred.

Underlying cause:	<ul style="list-style-type: none">• failure to comply of the external worker obligation to take reasonable care of his safety and health, do not enter into the operated railway infrastructure without concentration on traffic and during the movement of the train to monitor the passing rolling stocks.
Root cause:	none.
Recommendation:	not issued.

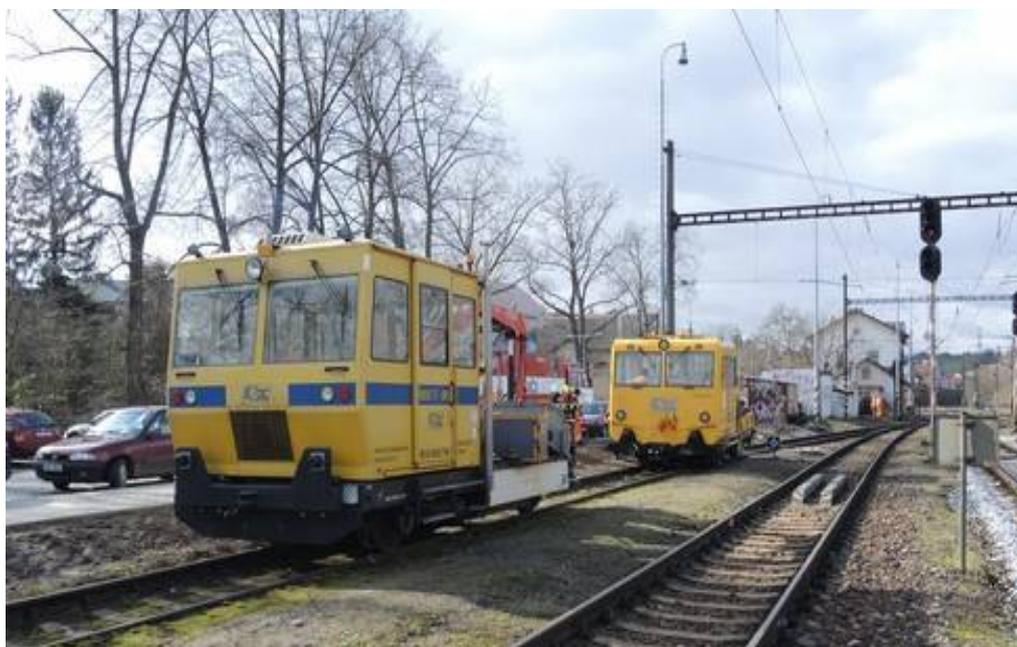
Grade:	incident.
Date and time:	28 th February 2020, 9:15 (8:15 GMT).
Occurrence type:	train derailment.
Description:	unsecured movement of the service train No. 57394 with consequent derailment and collision with a standing special rolling stock.
Type of train:	the service train No. 57394; the special rolling stock.
Location:	Řevnice station, switch No. 9, km 23,834; place of the derailment was at the derailer Vk2, station track No. 5, km 23,777.
Parties:	Správa železnic, s. o. (IM and RU of the service train No. 57394).
Consequences:	0 fatality, 0 injury; total damage CZK 237 987,-
Direct cause:	<ul style="list-style-type: none">• an unintended movement of the service train No. 57394 through the switch No. 9 which was switched into the wrong (branching-off) direction to station track No. 5.
Contributory factor:	none.
Underlying cause:	<ul style="list-style-type: none">• disconnection of the switch No. 9 of the Řevnice station from mechanical point machine and from central creation of the train routes without taking appropriate traffic measures within the repair works.

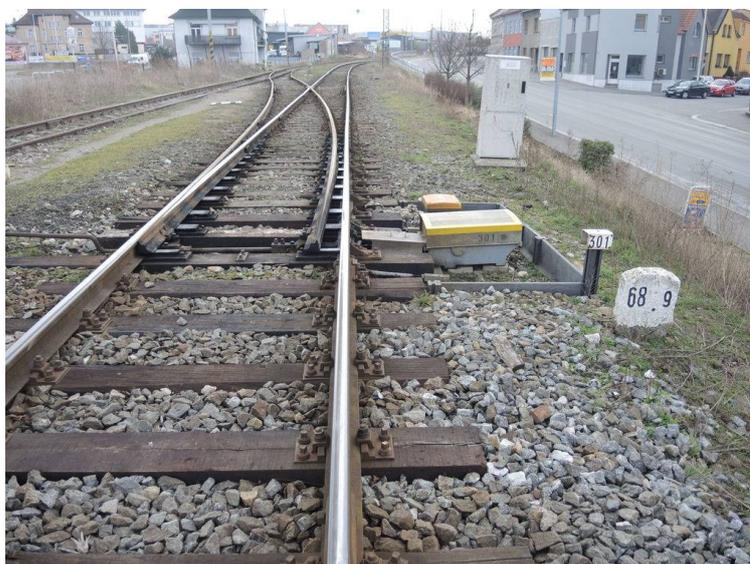
Grade:	an accident.
Date and time:	28 th February 2020, 6:13 (5:13 GMT).
Occurrence type:	an accident to a person caused by the rolling stock in motion.
Description:	the collision of the regional passenger train No. 18402 with the worker (the employee of the infrastructure manager).
Type of train:	the regional passenger train No. 18402.
Location:	a line between Horní Cerekev and Tábor stations, Tábor station, the switch No. 301, km 68,891.
Parties:	Správa železnic, státní organizace (the IM); České dráhy, a. s. (the RU of the regional passenger train No. 18402).
Consequences:	1 fatality; total damage CZK 6 140,-
Direct cause:	<ul style="list-style-type: none">the employee of the IM was moving in the operated train route and he did not leave the structure gauge while the train No. 18402 was moving.
Contributory factor:	none.
Underlying causes:	<ul style="list-style-type: none">failure to comply the established technological procedures of the IM for activities in the operated non-excluded track when employees move, stay and make activities in this track;failure to check and require the fulfillment of the ordered safety measures which result in situation when safety of the killed employee of the IM during his movement, stay and activity in the track was not ensured.

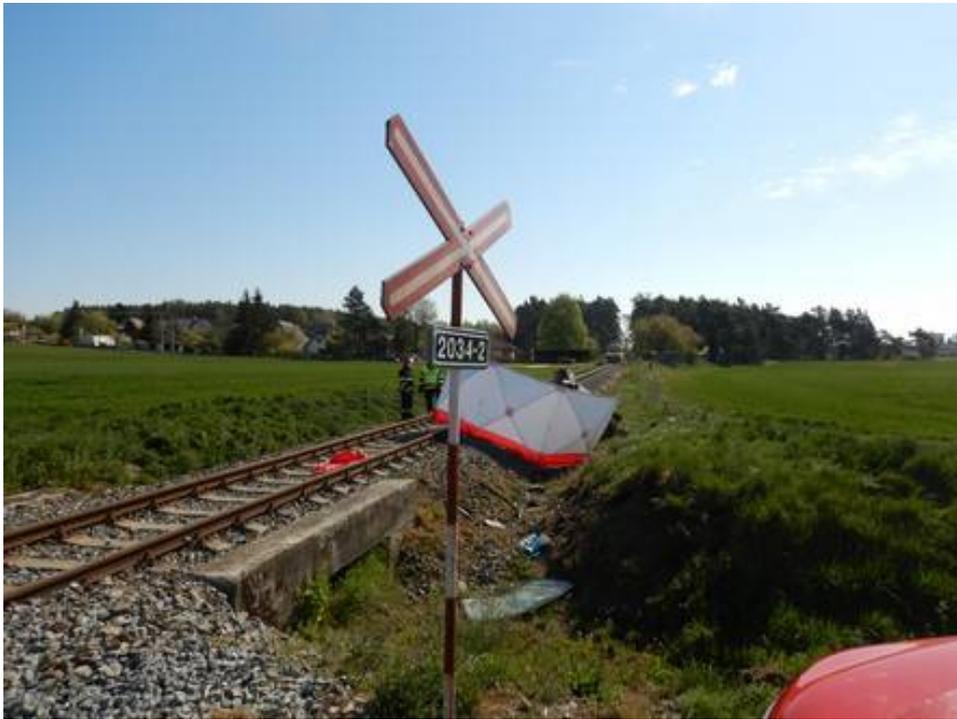
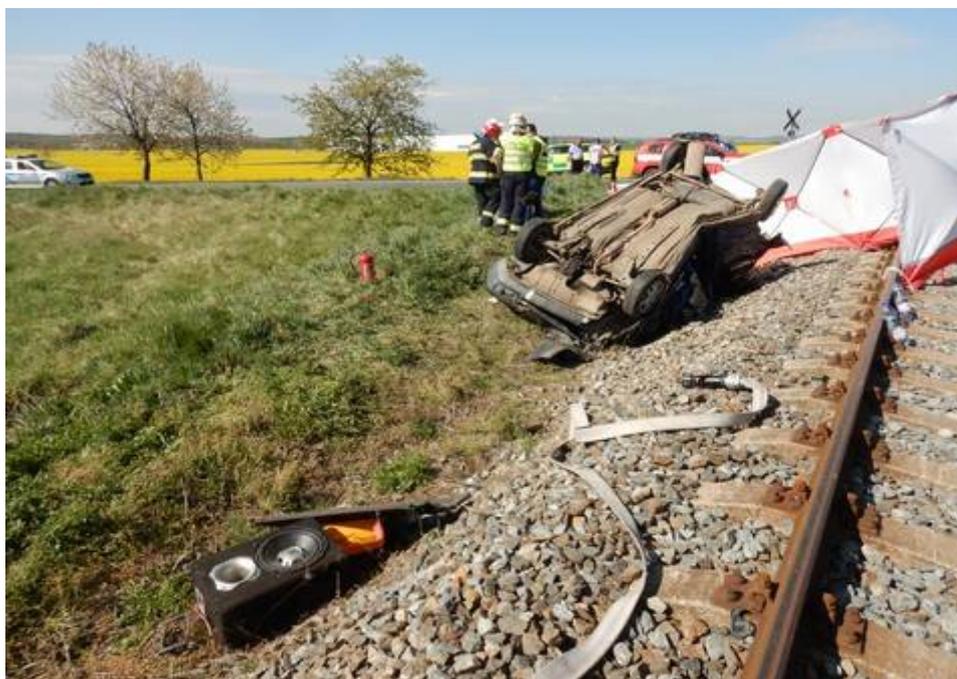
Grade:	accident.
Date and time:	27 th April 2020, 9:10 (7:10 GMT).
Occurrence type:	level crossing accident.
Description:	collision of the regional passenger train No. 27413 with a car at the level crossing.
Type of train:	the regional passenger train No. 27413.
Location:	open line between Heřmanova Huť operating control point and Nýřany station, the level crossing No. P647, km 1,856.
Parties:	Správa železnic, s. o. (IM); České dráhy, a. s. (RU of the regional passenger train No. 27413); driver of the car (level crossing user).
Consequences:	4 fatalities, 1 injury; total damage CZK 776 200,-
Direct cause:	<ul style="list-style-type: none">• an unauthorized entrance of the car at the level crossing No. P647 at the time when the train No. 27413 was arriving.
Contributory factor:	none.
Underlying cause:	<ul style="list-style-type: none">• the car driver was not careful in front of the level crossing No. P647 and he did not convince if he could safely proceed over the level crossing.

Root cause:	none.
Recommendations:	
Addressed to The Czech National Safety Authority (NSA):	<ul style="list-style-type: none">• it is recommended to adopt own measure for implementation of the previously issued safety recommendations so that only the level crossing safety equipment with warning lights and barriers will be designed, installed and approved during the reconstruction and modernization of the railway tracks and level crossings, including the level crossing No. P647;• it is recommended to adopt own measure to ensure that at the level crossing No. P647 which is currently secured only by a warning cross will be the road markings at this level crossing immediately equipped with a yellow-green retroreflective substructure;• it is recommended to adopt own measure to ensure that in the sighting distances for road vehicles at the level crossing No. P647 will not to adjacent cultivated fields sown with crops that restrict the view of the track by their height, i.e. that sighting distances will be provided for drivers of road vehicles in all quadrants of level crossing.

Addressed to the Municipal Authority of Nýřany as the Road Administration Office in cases of the III. class roads:	<ul style="list-style-type: none">• it is recommended to adopt a measure to ensure that vertical traffic sign A 31a „Signal board” (240 m) supplemented by traffic sign A 30 „Level crossing without barriers”, A 31b „Signal board” (160 m) and A 31c „Signal board” (80 m) located in front of the level crossing No. P647 in both directions, will be equipped with a yellow-green retroreflective substructure;

- it is recommended to adopt a measure to ensure that on road III. Class, No. 2034 in both directions in front of the level crossing No. P647, which is currently secured only by a warning crosses, will be added the horizontal traffic sign V18 "Optical psychological brake";
- it is recommended to adopt a measure to ensure that on road III. Class, No. 2034 in both directions in front of the level crossing No. P647, which is currently secured only by warning crosses, will be supplemented horizontal traffic sign V15 "Road sign" – A 32a "Warning cross for single-track level crossing" with possible addition of horizontal traffic sign V15 "Sign on the road" – A30 „Level crossing without barriers".

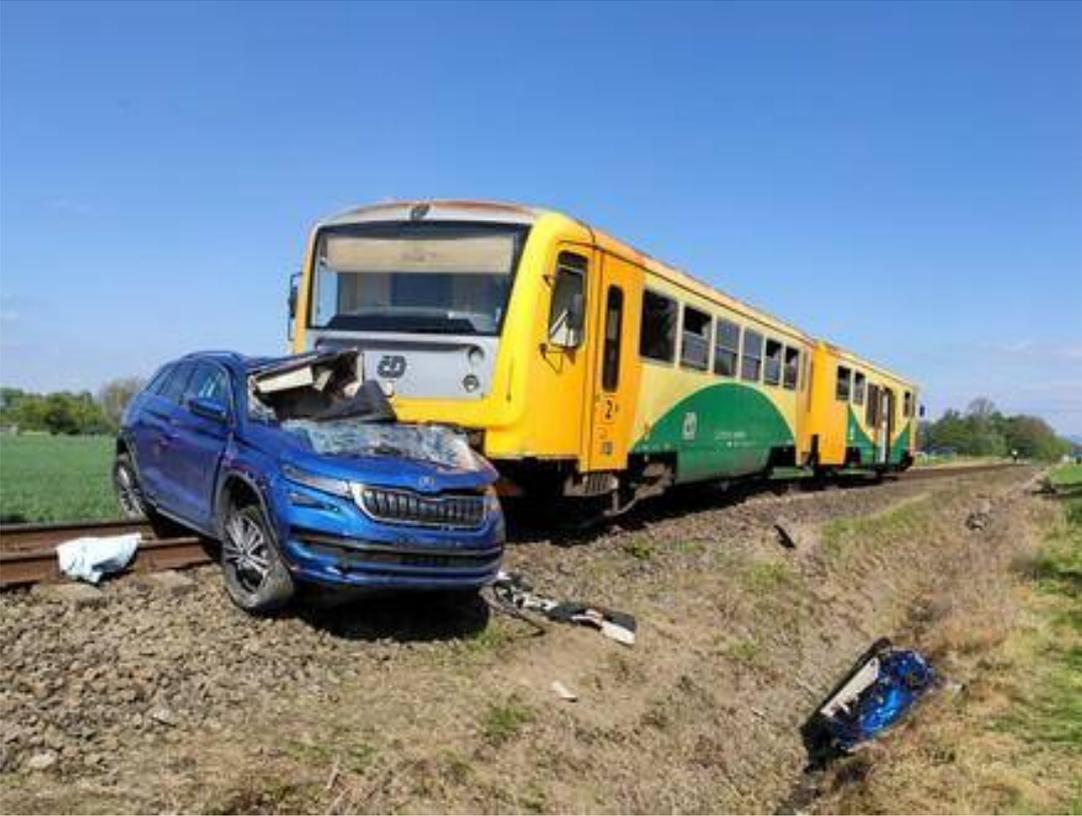
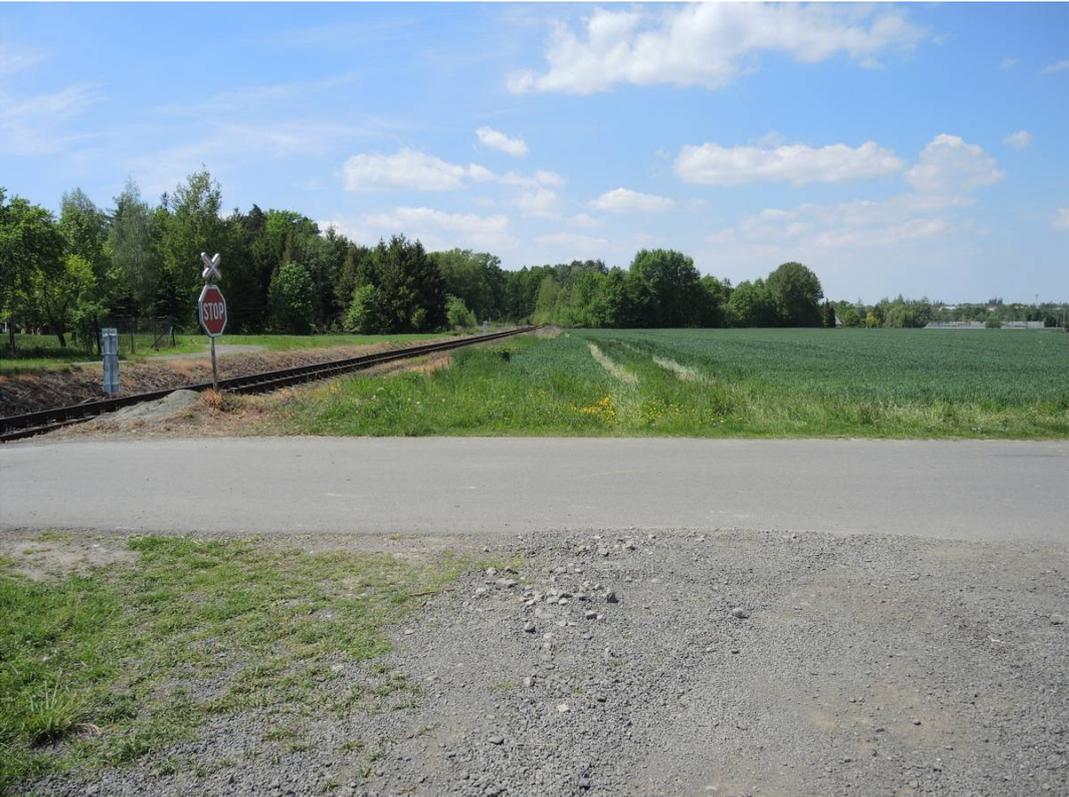
Date and time:	16 th May 2015, 7:41 (5:41 GMT).
Occurrence type:	a level crossing accident.
Description:	the collision of the regional passenger train No. 12818 with the car at the level crossing No. P8324 and its consequent derailment.
Type of train:	the regional passenger train No. 12818.
Location:	a railway track Český Těšín – Frýdek-Místek, the level crossing No. P8324, km 125,250.
Parties:	Správa železnic, státní organizace (the IM); České dráhy, a. s. (the RU of the regional passenger train No. 12818); the car driver (a level crossing user).
Consequences:	2 injuries; total damage CZK 1 738 800,-
Causal factor:	<ul style="list-style-type: none">• an unauthorized entrance of the car at the level crossing No. P8324 at the time when the train No. 12818 was arriving, caused by behavior of the car driver, who did not respect the traffic sign „Stop, give a priority!” and did not stop the car at a place where she would have a proper view of the track and did not make sure whether she could safely pass the level crossing.

Contributing factor:	none
Systemic factor:	none
Recommendation:	
Addressed to the Czech National Safety Authority (the NSA):	<ul style="list-style-type: none">• it is recommended to adopt own measure to ensure that:<ul style="list-style-type: none">◦ the change of the method of securing of the level crossing No. P8324 will be realized as fast as possible, the traffic torque is exceeding 10,000 and it has a value of up to 28,800 when taking into account the fiftieth highest annual traffic flow volume of traffic flow, so that in connection with the previously issued safety recommendations, this level crossing should be secured by flashing light level crossing warning system and supplemented by barriers;◦ the warning crosses of the level crossing No. P8324, including vertical traffic signs P 6 „Stop, give a priority!”, should be provided with a retroreflective fluorescent yellow-green background until the change of securing of the level crossing No. P8324 will be realized.

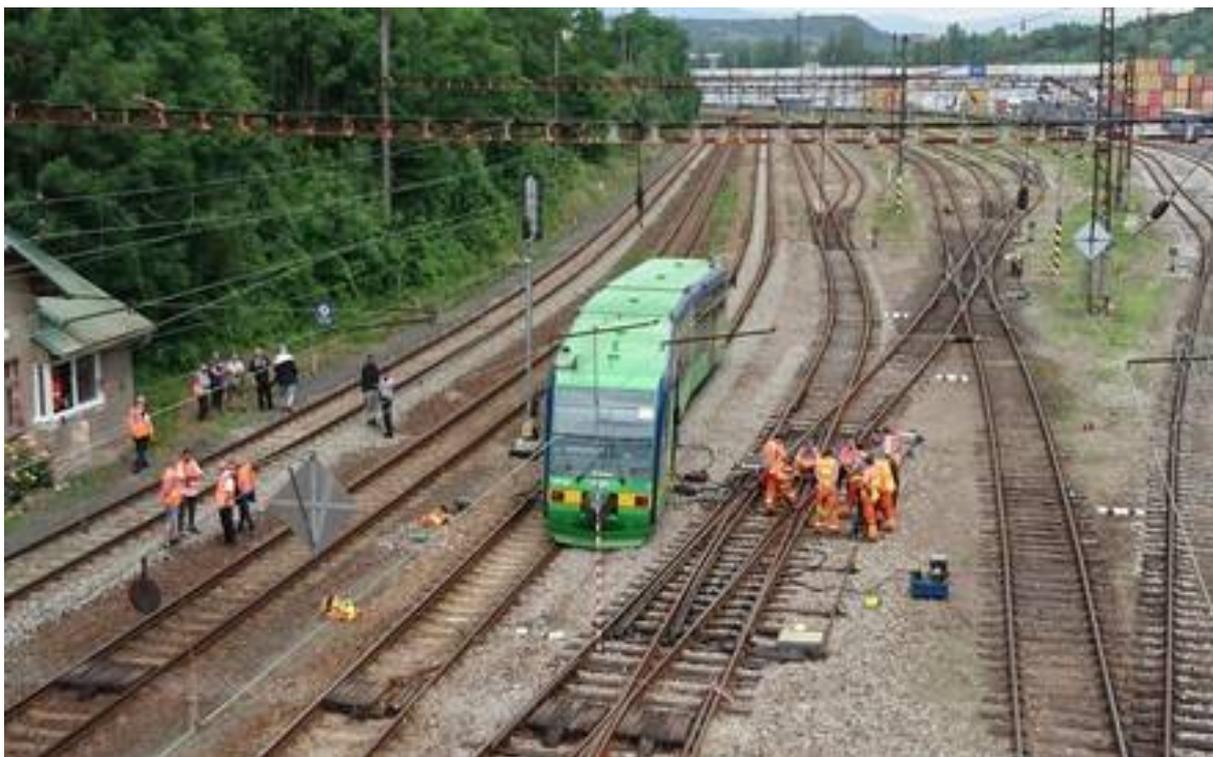
Date and time: 18th June 2020, 8:05 (6:05 GMT).
Occurrence type: train derailment.
Description: derailment of the regional passenger train No. 6704.
Type of train: the regional passenger train No. 6704.
Location: Obrnice station, switch No. 25a, km 117,939.
Parties: Správa železnic, státní organizace (IM);
Die Länderbahn CZ s. r. o. (RU of the regional passenger train No. 6704).
Consequences: 0 fatality, 0 injury;
total damage CZK 138 701,-
Causal factor:

- unauthorized change of position of the switch No. 25a at the time, when the rolling stocks of the train No. 6704 were on the switch, which was preceded by a failure to detect whether the train No. 6704 has arrived whole at the designated track and premature cancellation of train route for this train.

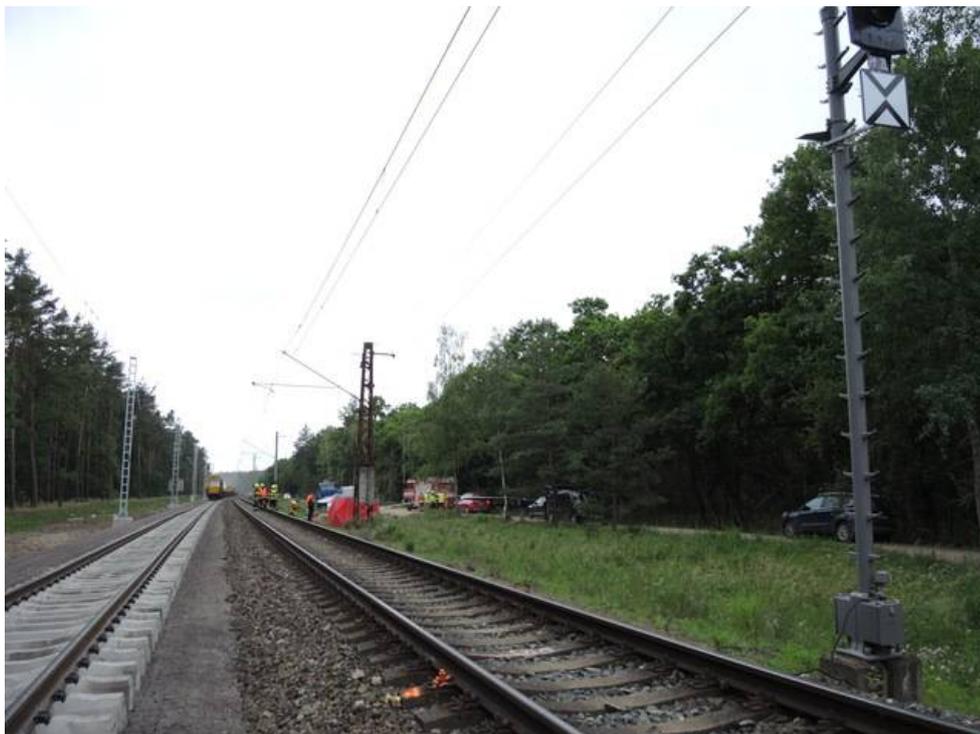
Date and time:	18 th June 2020, 14:46/14:59 (12:46/12:59 GMT).
Occurrence type:	accident to person caused by rolling stock in motion.
Description:	collision of the regional passenger train No. 9143 or No. 9419 with an external worker at operated open line track No. 2.
Type of train:	the regional passenger train No. 9143 or No. 9419.
Location:	open line between Lysá nad Labem station and Káraný junction point, track line No. 2, km 3,645.
Parties:	SŽ, s. o. (IM); ČD, a. s. (RU of the regional passenger train No. 9143 and No. 9419); the external worker (employee of maintenance service company ANIRAM, s. r. o.).
Consequences:	1 fatality, 0 injury; total damage CZK 0,-
Causal factor:	<ul style="list-style-type: none">• unauthorized entry of the external worker performing the activity as a security patrol into the structure gauge of operated open line track No. 2 while the regional passenger train No. 9143 or No. 9419 was moving around the working place.

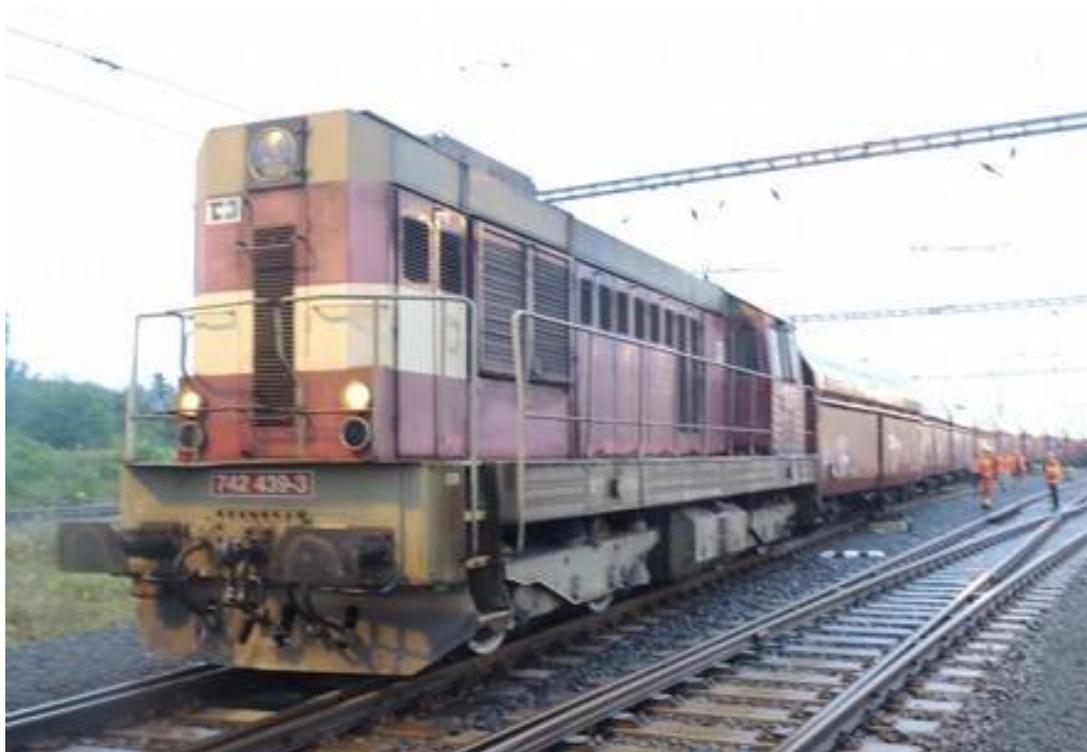
Date and time: 25th June 2020, 1:20 (24th June 2020, 23:20 GMT).
Occurrence type: the train derailment.
Description: derailment of the freight train No. 86658.
Type of train: the freight train No. 86658.
Location: Most nové nádraží station, switch No. 32, km 2,251.
Parties: Správa železnic, státní organizace (IM);
ČD Cargo, a. s. (RU of the freight train No. 86658).
Consequences: 0 fatality, 0 injury;
total damage CZK 904 295,-
Direct cause:

- not remove of device for securing the rolling stock against uncontrolled movement – the rail skate from the rail before the movement of the rolling stocks of the freight train No. 86658.

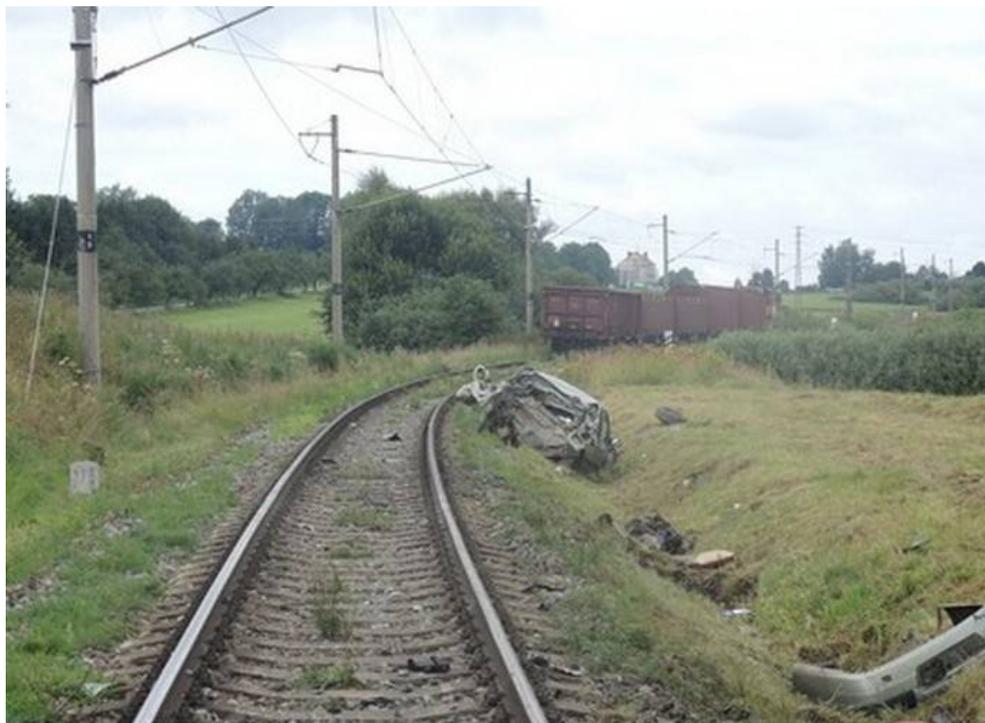
Consequences: 1 fatality, 0 injury;
total damage CZK 224 459,-

- an unauthorized entrance of the car at the level crossing No. P6189 at the time when the train No. 60430 was arriving, caused by behavior of the car driver, who did not respect the traffic sign „Stop, give a priority!” and did not stop the car at a place where she would have a proper view of the track and did not make sure whether she could safely pass the level crossing.
